TREE MANAGEMENT PLAN

1 - 8 Main Drive, Kew.

8 OCTOBER 2019

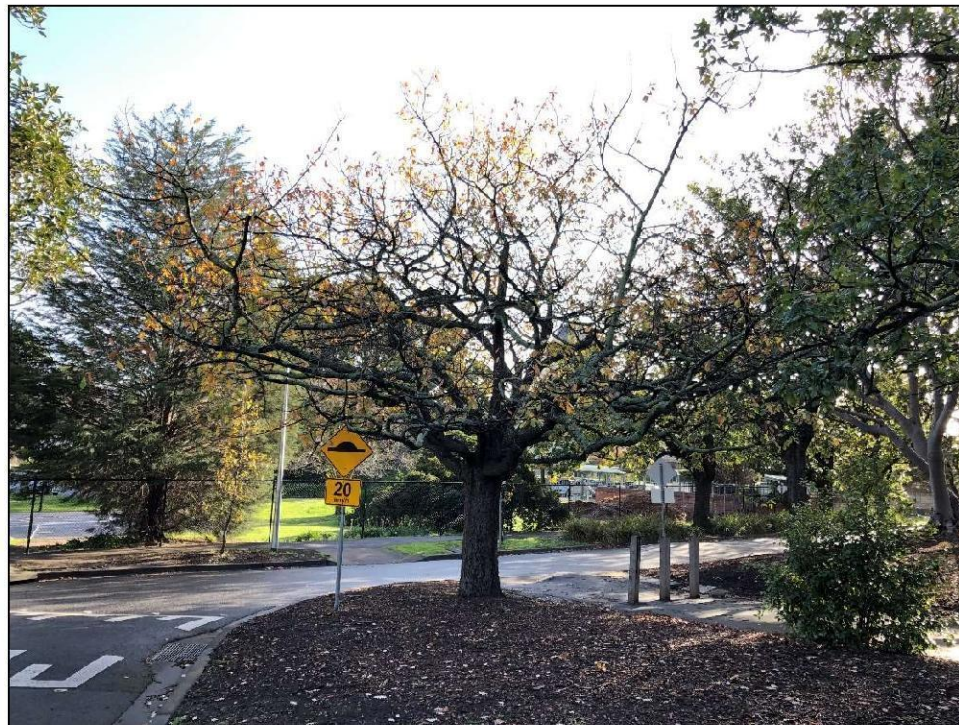
Tree No. 1.

Tree No.:	1
Existing Tree No.:	1107
Botanic Name:	Quercus canariensis
Common Name:	Algerian Oak
Origin:	Exotic
Size (m):	8 x 13
DBH (cm):	55
TPZ (m):	6.6
Age:	Mature
Health:	Good
Structure:	Good
ULE (years):	20+
Arb. Value	High
Comments / Works:	Check decay in main branch union.

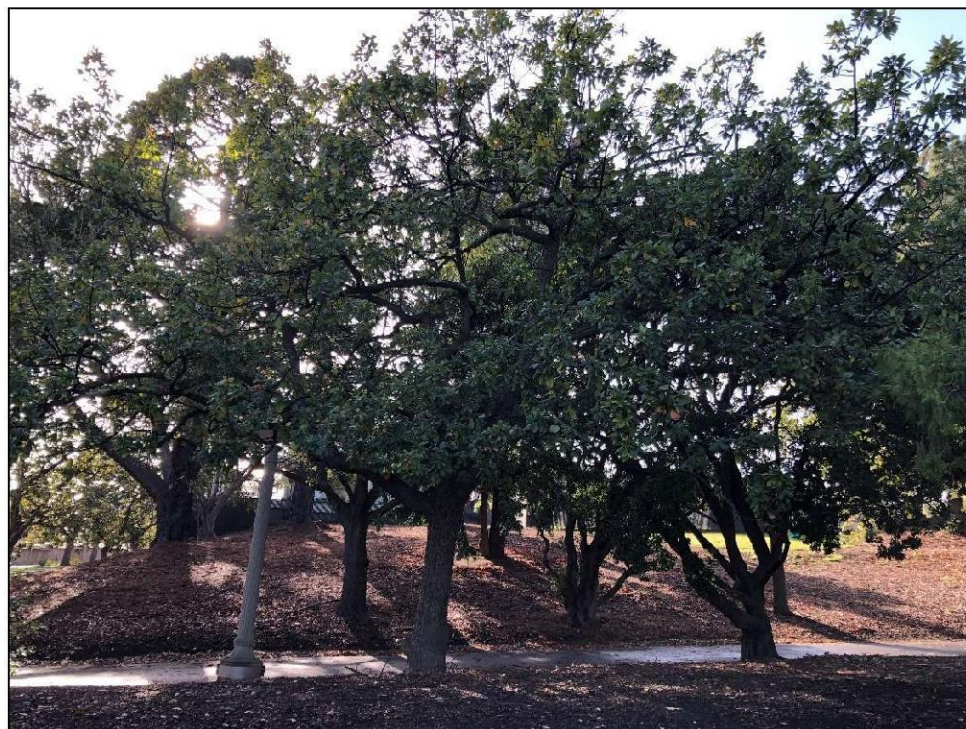
**Tree No. 2.**

Tree No.:	2
Existing Tree No.:	1109
Botanic Name:	Quercus canariensis
Common Name:	Algerian Oak
Origin:	Exotic
Size (m):	8 x 12
DBH (cm):	36
TPZ (m):	4.3
Age:	Mature
Health:	Fair
Structure:	Fair
ULE (years):	20+
Arb. Value	High
Comments / Works:	Partly suppressed by 2.

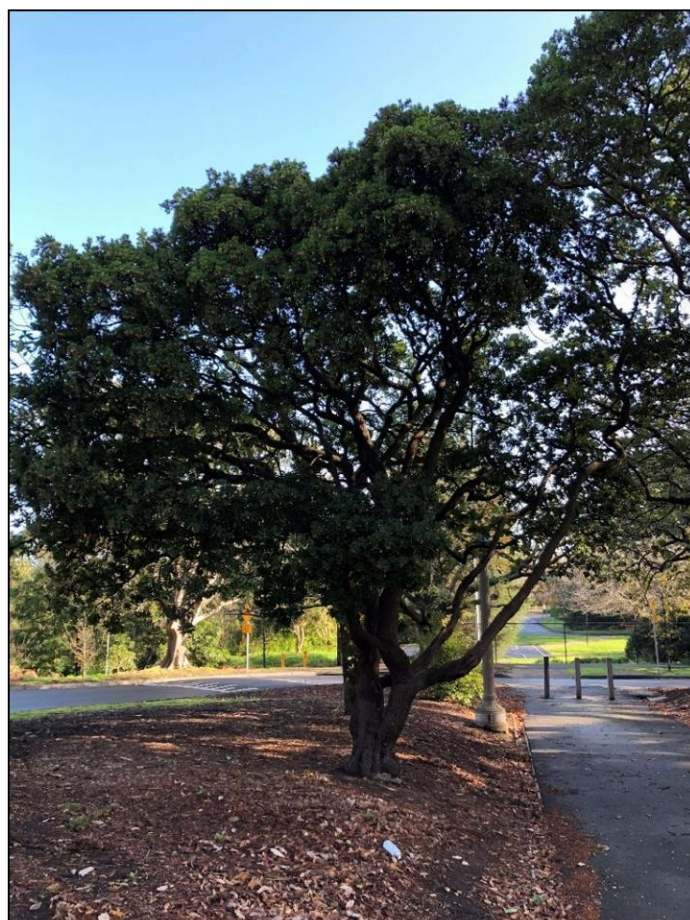
**Tree No. 3.**

Tree No.:	3
Existing Tree No.:	1111
Botanic Name:	Arbutus unedo
Common Name:	Irish Strawberry Tree
Origin:	Exotic
Size (m):	7 x 6
DBH (cm):	Multi 20
TPZ (m):	4.8
Age:	Mature
Health:	Good
Structure:	Fair
ULE (years):	20+
Arb. Value	High
Comments / Works:	-

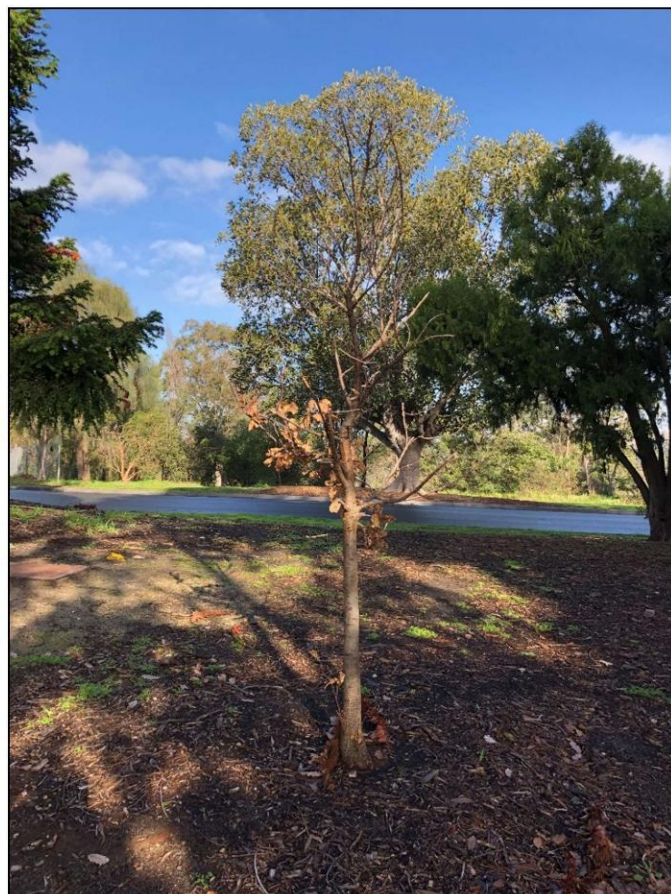
**Tree No. 4.**

Tree No.:	4
Existing Tree No.:	1113
Botanic Name:	Quercus canariensis
Common Name:	Algerian Oak
Origin:	Exotic
Size (m):	2 x 1
DBH (cm):	7
TPZ (m):	2.0
Age:	Juvenile
Health:	Dead
Structure:	Poor
ULE (years):	20+
Arb. Value	Low
Comments / Works:	98% dead. Remove and replace with same species.

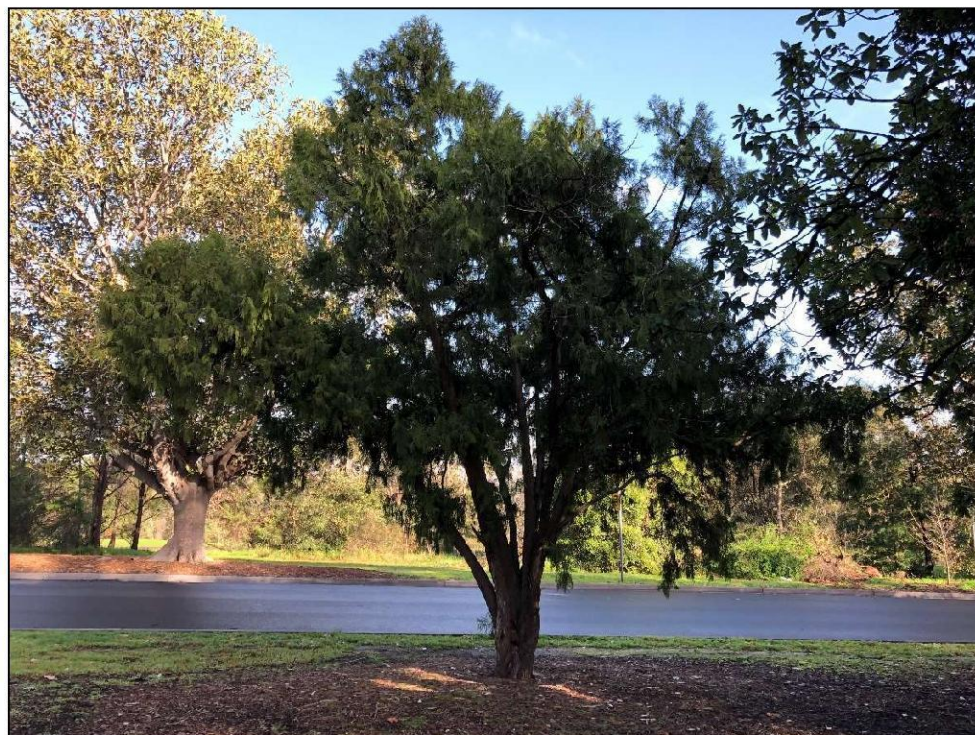
**Tree No. 5.**

Tree No.:	5
Existing Tree No.:	1112
Botanic Name:	Cupressus funiberis
Common Name:	Chinese Weeping Cypress
Origin:	Exotic
Size (m):	6 x 6
DBH (cm):	Multi 10
TPZ (m):	4.8
Age:	Mature
Health:	Fair
Structure:	Fair
ULE (years):	0 – 5
Arb. Value	Medium
Comments / Works:	Remove and replace with different species

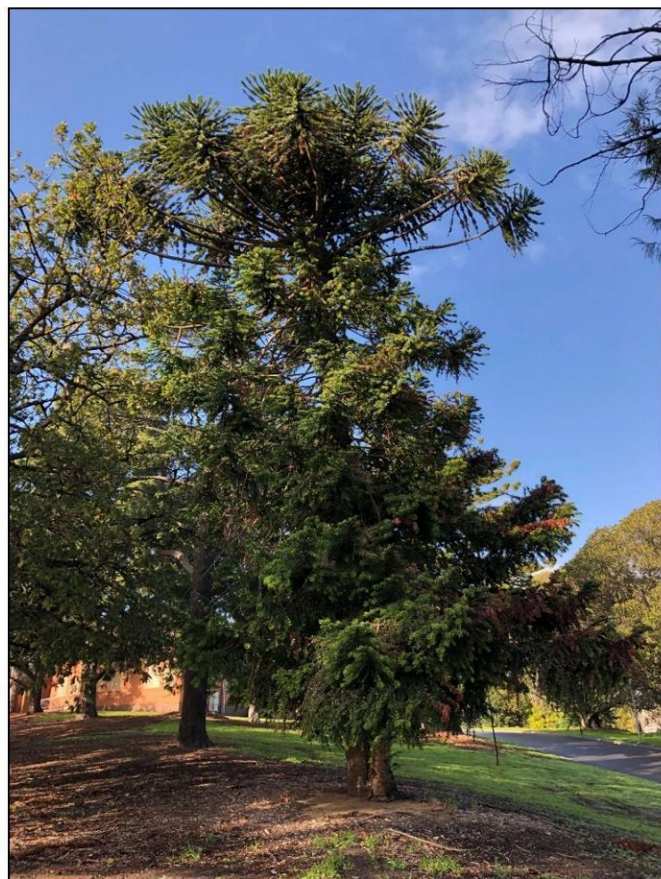
**Tree No. 6.**

Tree No.:	6
Existing Tree No.:	197
Botanic Name:	Araucaria bidwilli
Common Name:	Bunya Pine
Origin:	Aust. Native
Size (m):	10 x 5
DBH (cm):	51
TPZ (m):	6.1
Age:	Mature
Health:	Good
Structure:	Good
ULE (years):	20+
Arb. Value	High
Comments / Works:	Prune off twin leader at base.

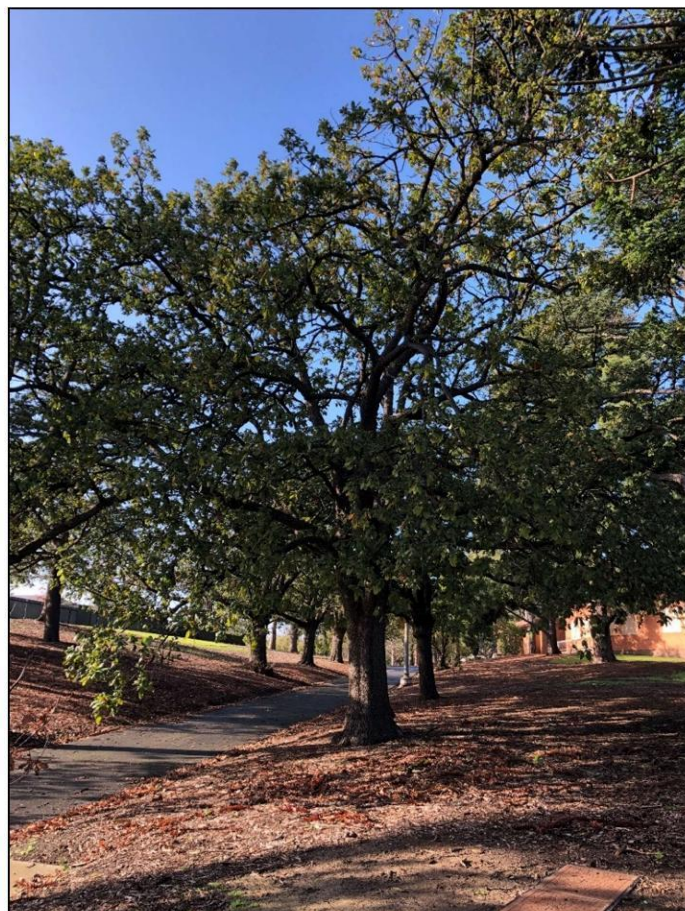
**Tree No. 7.**

Tree No.:	7
Existing Tree No.:	1116
Botanic Name:	Quercus canariensis
Common Name:	Algerian Oak
Origin:	Exotic
Size (m):	9 x 15
DBH (cm):	68
TPZ (m):	8.2
Age:	Mature
Health:	Good
Structure:	Good
ULE (years):	20+
Arb. Value	High
Comments / Works:	-

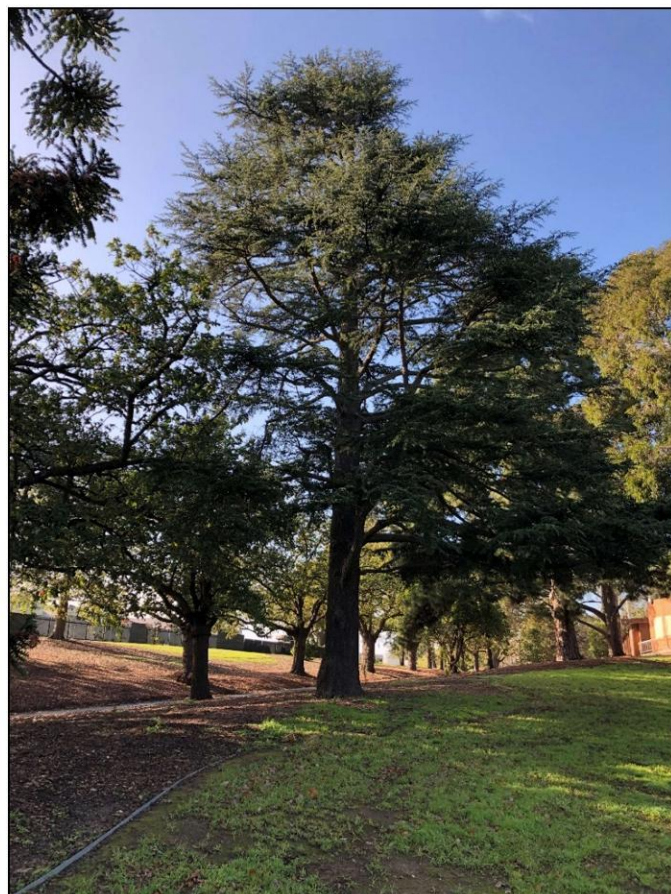
**Tree No. 8.**

Tree No.:	8
Existing Tree No.:	1120
Botanic Name:	Cedrus deodara
Common Name:	Himalayan Cedar
Origin:	Exotic
Size (m):	15 x 12
DBH (cm):	65
TPZ (m):	7.8
Age:	Mature
Health:	Good
Structure:	Good
ULE (years):	20+
Arb. Value	High
Comments / Works:	Prune out minor deadwood.

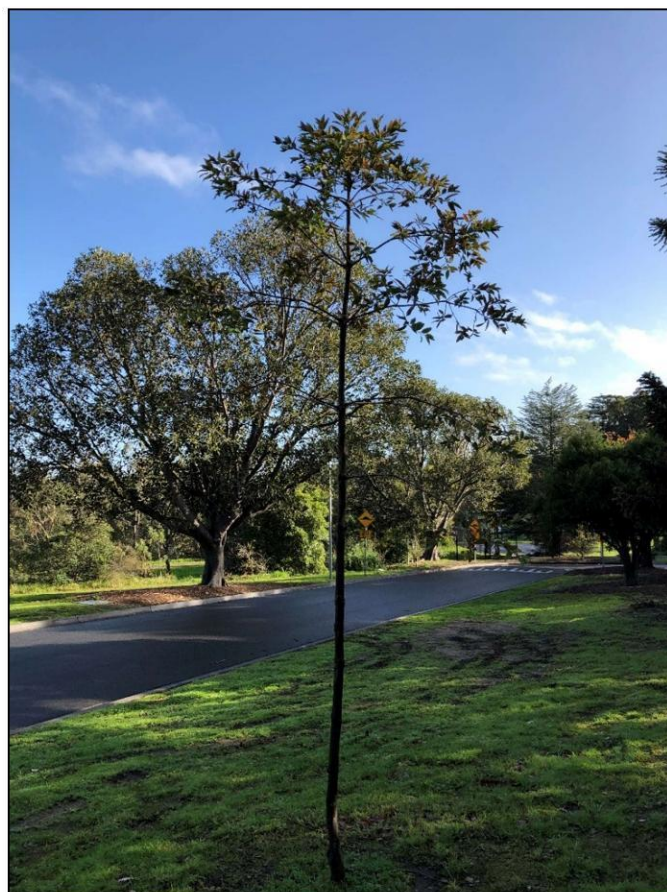
Tree No. 9.

Tree No.:	9
Existing Tree No.:	1120a
Botanic Name:	Agathis robusta
Common Name:	Kauri Pine
Origin:	Aust. Native
Size (m):	3 x 1
DBH (cm):	5
TPZ (m):	2.0
Age:	Juvenile
Health:	Fair
Structure:	Fair
ULE (years):	0 – 5
Arb. Value	Low
Comments / Works:	Appears to be stressed. Possibly pot bound. Soil amelioration.

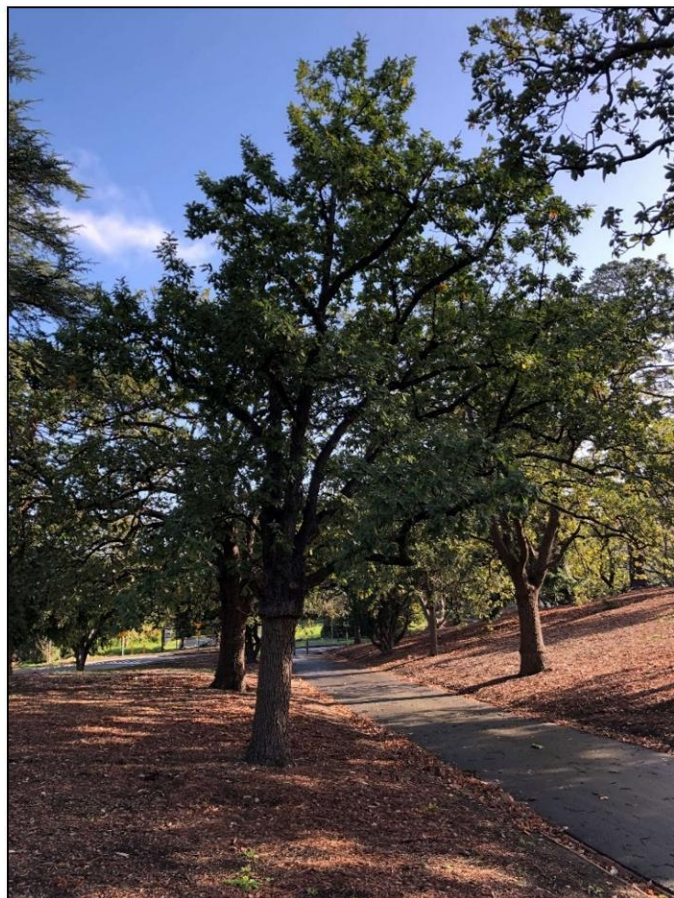
**Tree No. 10.**

Tree No.:	10
Existing Tree No.:	1119
Botanic Name:	Quercus canariensis
Common Name:	Algerian Oak
Origin:	Exotic
Size (m):	8 x 8
DBH (cm):	44
TPZ (m):	5.3
Age:	Mature
Health:	Good
Structure:	Fair
ULE (years):	20+
Arb. Value	High
Comments / Works:	-

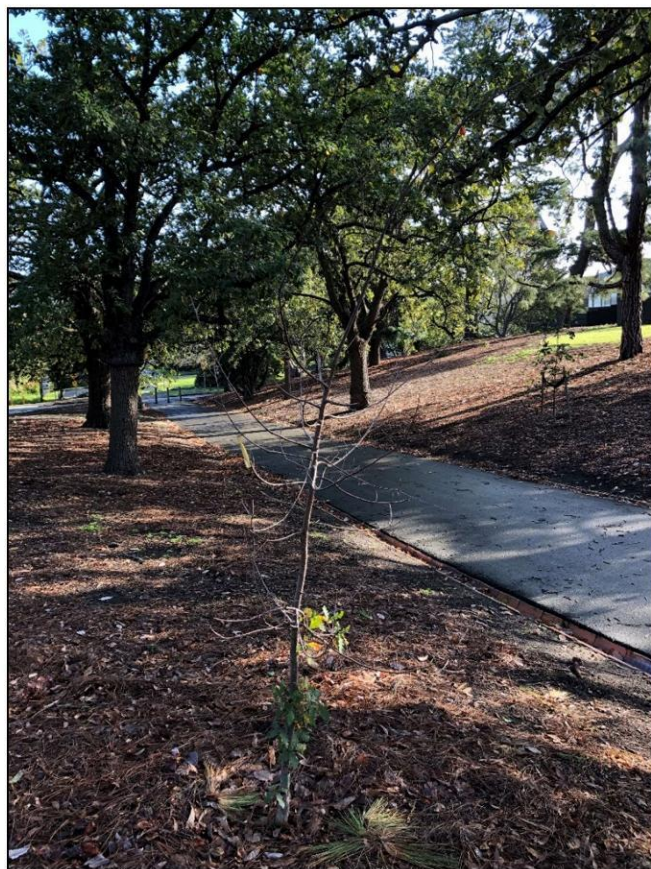
**Tree No. 11.**

Tree No.:	11
Existing Tree No.:	1123
Botanic Name:	Quercus canariensis
Common Name:	Algerian Oak
Origin:	Exotic
Size (m):	2 x 1
DBH (cm):	2
TPZ (m):	2.0
Age:	Juvenile
Health:	Dead
Structure:	Poor
ULE (years):	0
Arb. Value	Low
Comments / Works:	Remove and replace same species.

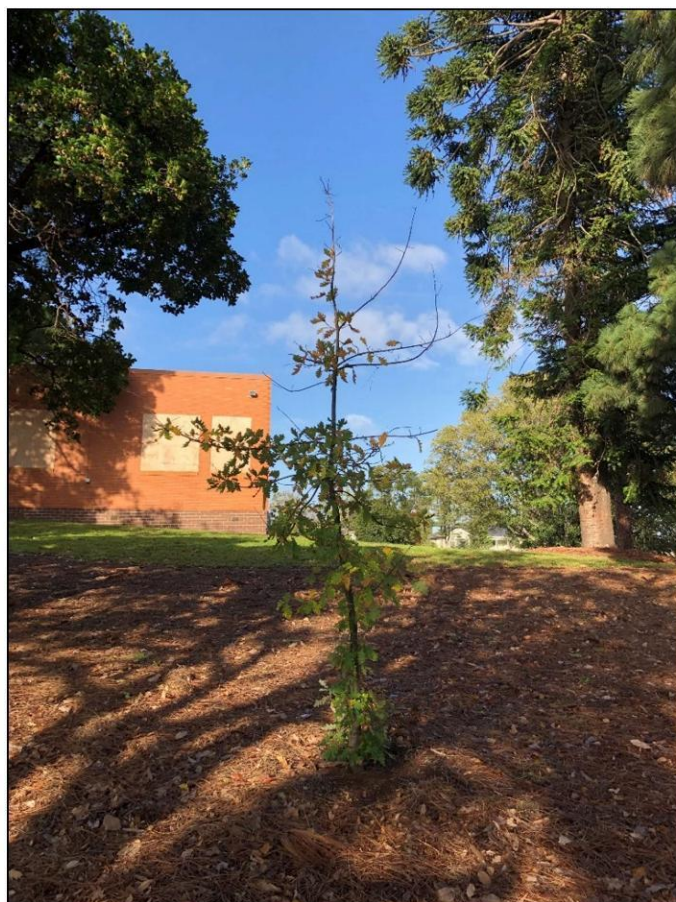
**Tree No. 12.**

Tree No.:	12
Existing Tree No.:	1127a
Botanic Name:	Quercus canariensis
Common Name:	Algerian Oak
Origin:	Exotic
Size (m):	2 x 1
DBH (cm):	2
TPZ (m):	2.0
Age:	Juvenile
Health:	Good
Structure:	Fair
ULE (years):	20+
Arb. Value	High
Comments / Works:	-

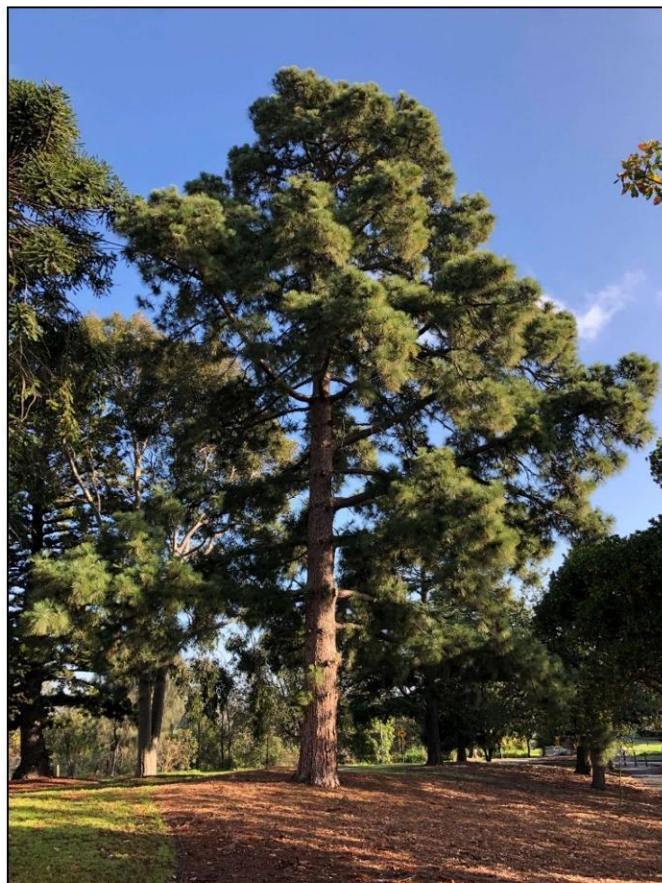
**Tree No. 13.**

Tree No.:	13
Existing Tree No.:	189
Botanic Name:	Pinus canariensis
Common Name:	Canary Island Pine
Origin:	Exotic
Size (m):	21 x 12
DBH (cm):	85
TPZ (m):	10.2
Age:	Mature
Health:	Good
Structure:	Good
ULE (years):	20+
Arb. Value	High
Comments / Works:	Prune out minor deadwood.

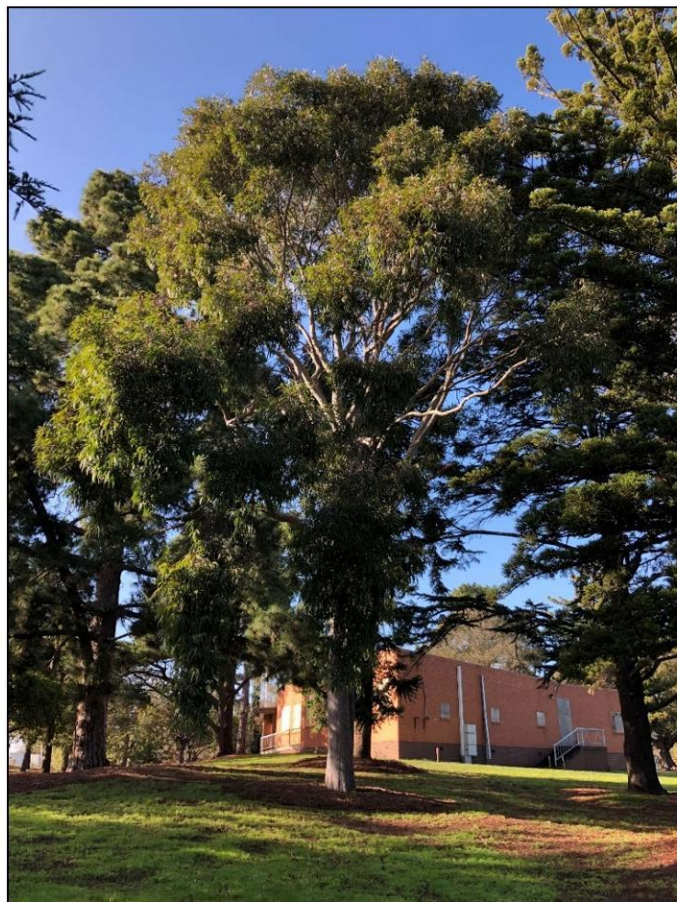
**Tree No. 14.**

Tree No.:	14
Existing Tree No.:	1125
Botanic Name:	Corymbia maculata
Common Name:	Spotted Gum
Origin:	Aust. Native
Size (m):	16 x 14
DBH (cm):	40/45
TPZ (m):	7.2
Age:	Mature
Health:	Good
Structure:	Fair
ULE (years):	10 – 20
Arb. Value	Medium
Comments / Works:	Remove and replace within 10 years.

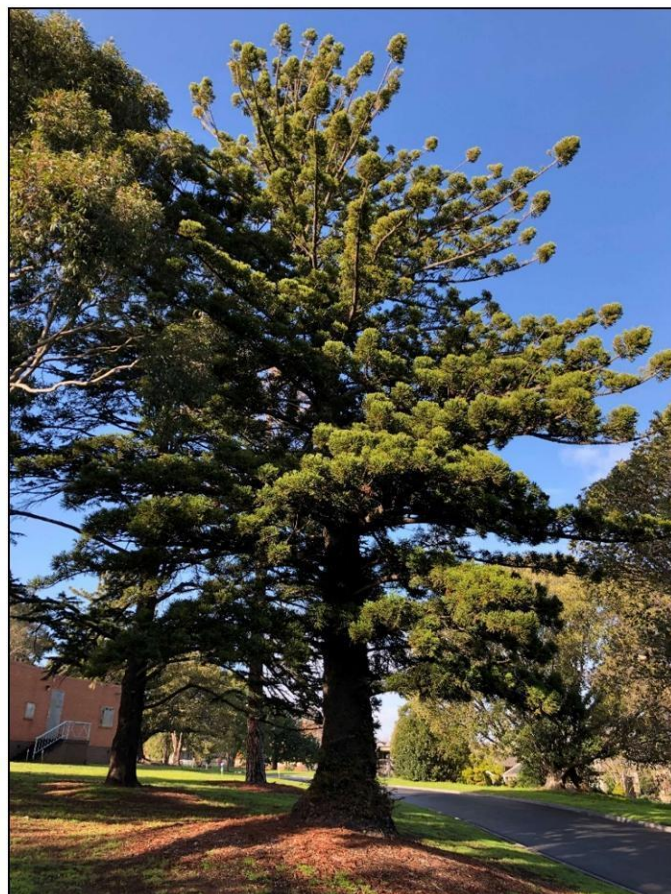
**Tree No. 15.**

Tree No.:	15
Existing Tree No.:	193
Botanic Name:	Araucaria cunninghamii
Common Name:	Hoop Pine
Origin:	Aust. Native
Size (m):	19 x 10
DBH (cm):	90
TPZ (m):	10.8
Age:	Mature
Health:	Good
Structure:	Good
ULE (years):	20+
Arb. Value	High
Comments / Works:	-

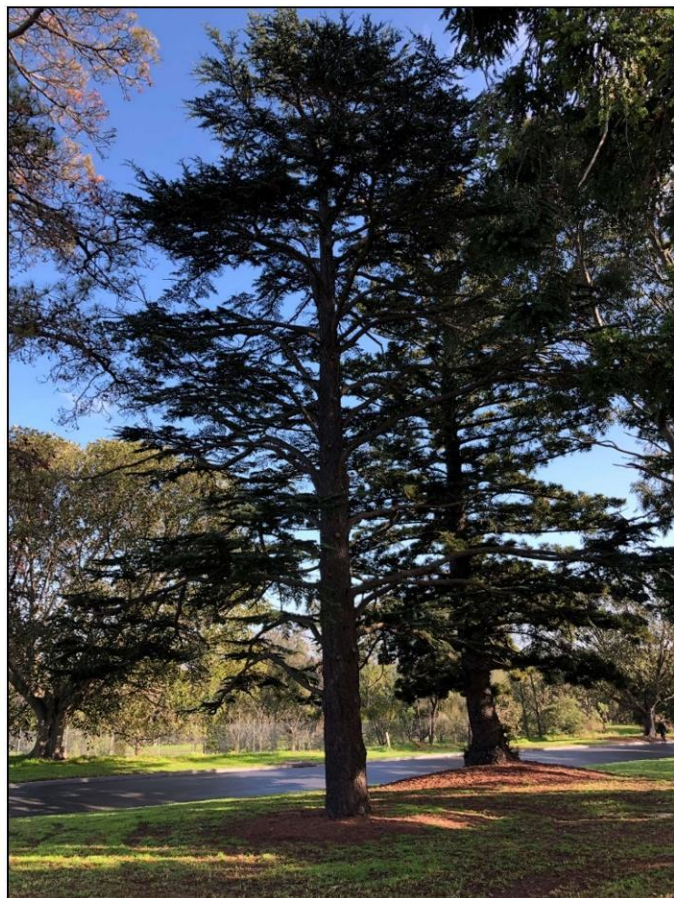
**Tree No. 16.**

Tree No.:	16
Existing Tree No.:	1126
Botanic Name:	Cedrus deodara
Common Name:	Himalayan Cedar
Origin:	Exotic
Size (m):	16 x 15
DBH (cm):	70
TPZ (m):	8.4
Age:	Mature
Health:	Good
Structure:	Good
ULE (years):	20+
Arb. Value	High
Comments / Works:	-

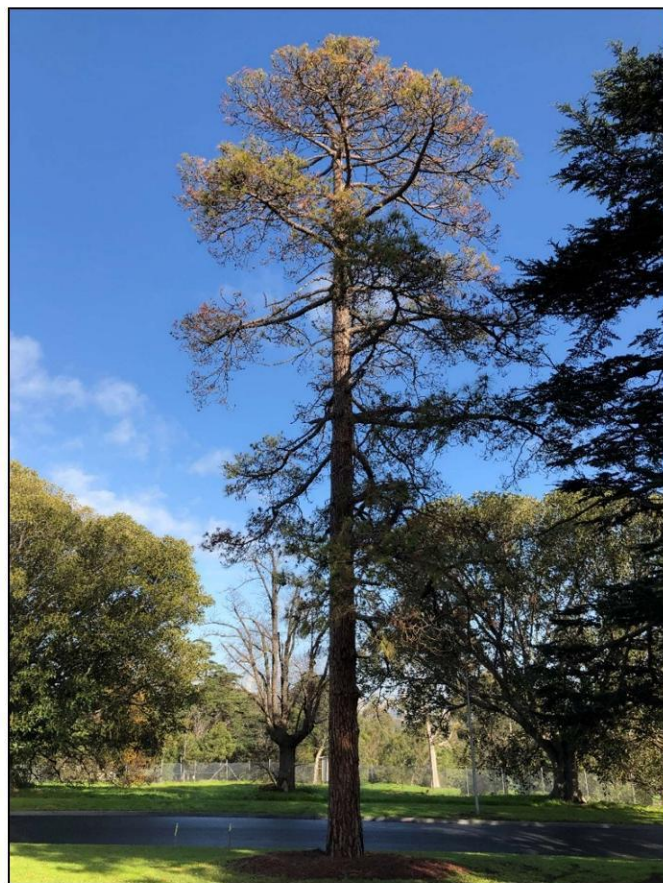
**Tree No. 17.**

Tree No.:	17
Existing Tree No.:	191
Botanic Name:	Pinus canariensis
Common Name:	Canary Island Pine
Origin:	Exotic
Size (m):	20 x 14
DBH (cm):	66
TPZ (m):	7.9
Age:	Mature
Health:	Poor
Structure:	Poor
ULE (years):	0 – 5
Arb. Value	Low
Comments / Works:	In decline but showing signs of new growth after irrigating.

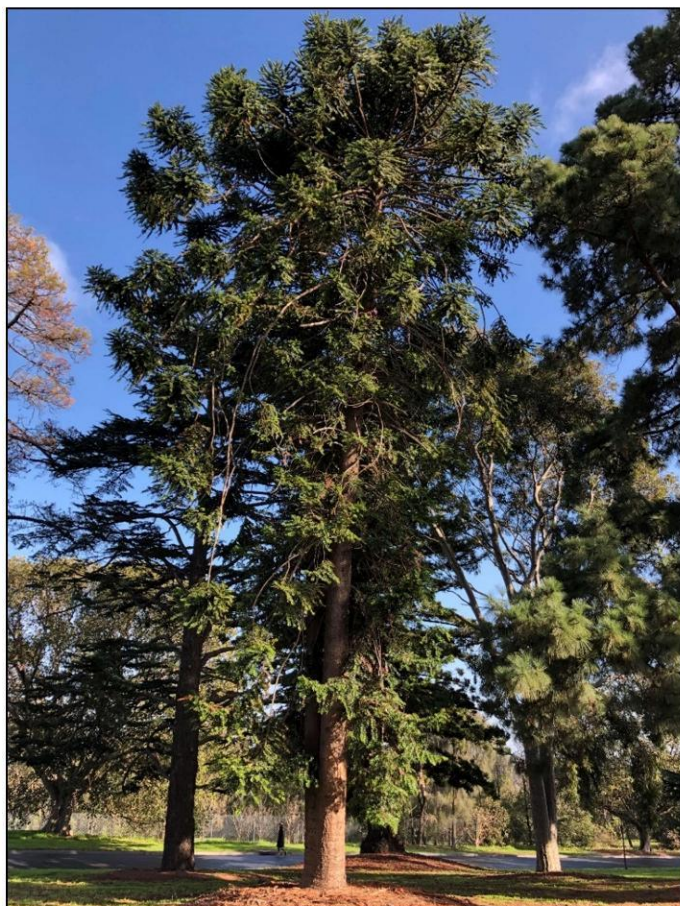
**Tree No. 18.**

Tree No.:	18
Existing Tree No.:	190
Botanic Name:	Araucaria Bidwillii
Common Name:	Bunya Pine
Origin:	Aust. Native
Size (m):	17 x 7
DBH (cm):	75
TPZ (m):	9.0
Age:	Mature
Health:	Good
Structure:	Poor
ULE (years):	5 – 10
Arb. Value	Medium
Comments / Works:	Significant bifurcation. Remove and replace.

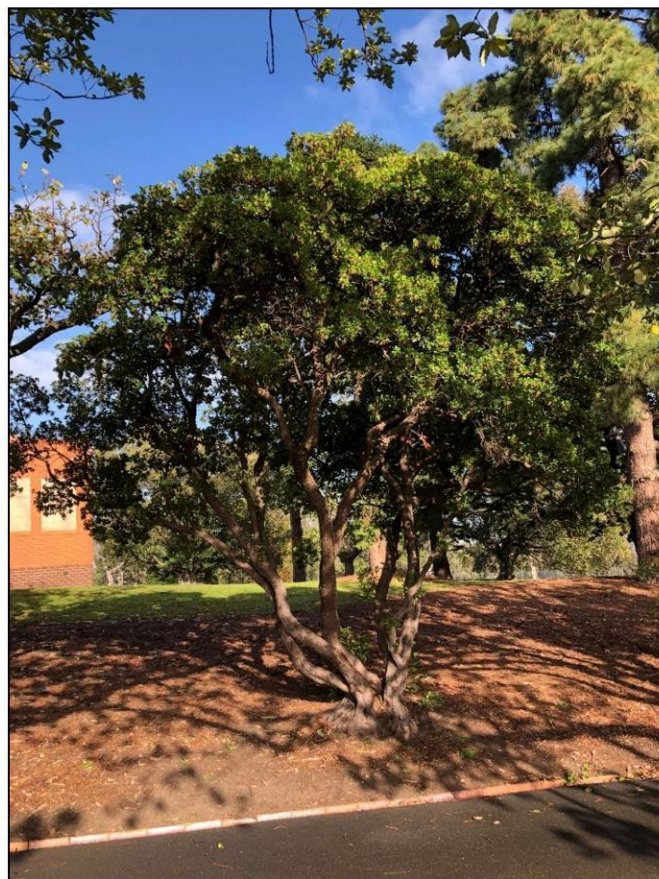
**Tree No. 19.**

Tree No.	19
Existing Tree No.:	1127
Botanic Name:	Arbutus unedo
Common Name:	Irish Strawberry Tree
Origin:	Exotic
Size (m):	6 x 9
DBH (cm):	Multi 15
TPZ (m):	4.8
Age:	Mature
Health:	Good
Structure:	Fair
ULE (years):	20+
Arb. Value	Medium
Comments / Works:	Not consistent with avenue, not replicated other side.

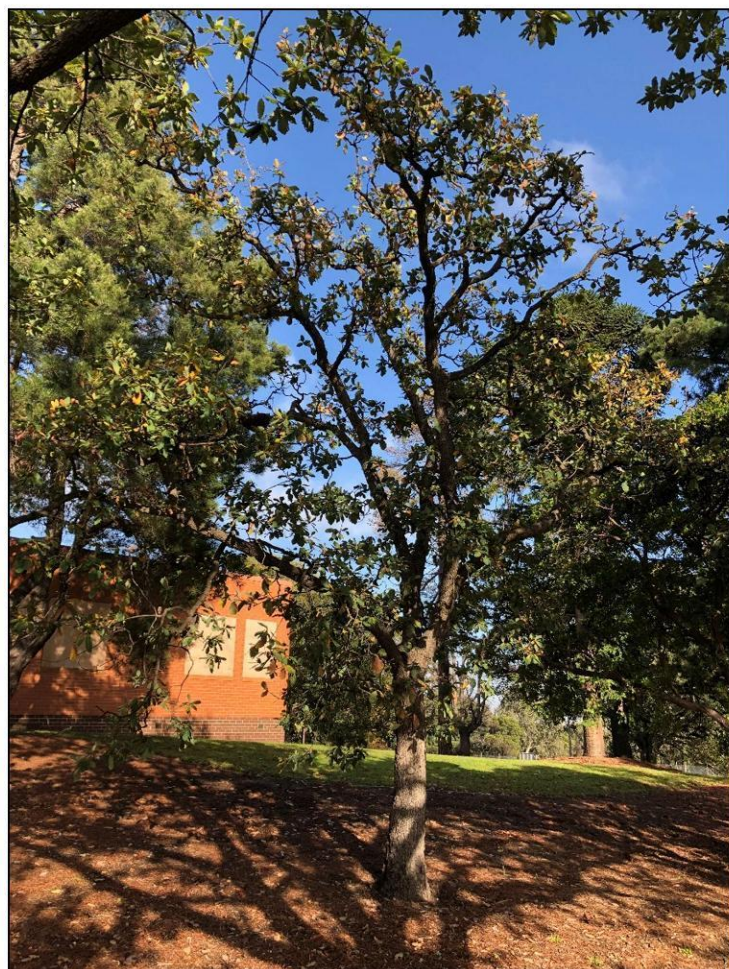
Tree No. 20.

Tree No.:	20
Existing Tree No.:	1131
Botanic Name:	Quercus canariensis
Common Name:	Algerian Oak
Origin:	Exotic
Size (m):	8 x 9
DBH (cm):	32
TPZ (m):	3.8
Age:	Mature
Health:	Good
Structure:	Fair
ULE (years):	20+
Arb. Value	High
Comments / Works:	-

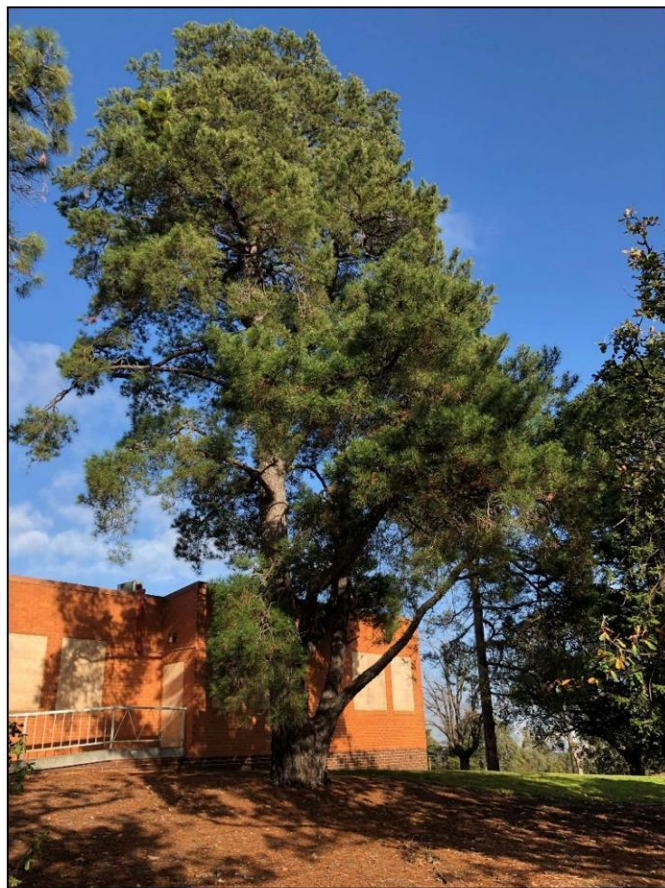
**Tree No. 21.**

Tree No.:	21
Existing Tree No.:	186
Botanic Name:	Pinus radiata
Common Name:	Monterey Pine
Origin:	Exotic
Size (m):	18 x 15
DBH (cm):	80
TPZ (m):	9.6
Age:	Mature
Health:	Good
Structure:	Fair
ULE (years):	5 – 10
Arb. Value	Medium
Comments / Works:	Remove within 10 years. No replacement.

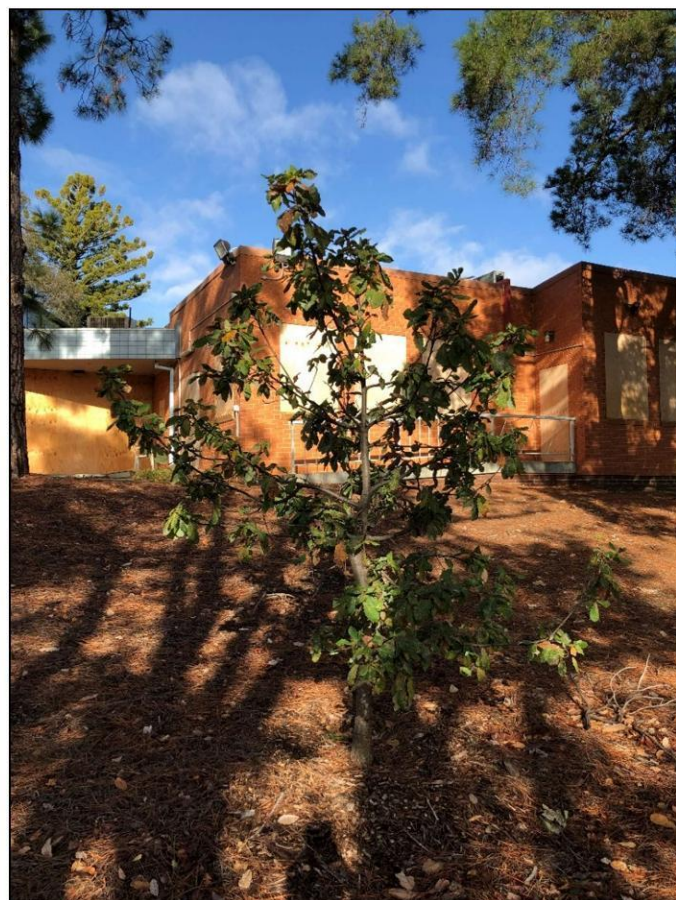
**Tree No. 22.**

Tree No.:	22
Existing Tree No.:	185a
Botanic Name:	Quercus canariensis
Common Name:	Algerian Oak
Origin:	Exotic
Size (m):	2 x 2
DBH (cm):	4
TPZ (m):	2.0
Age:	Juvenile
Health:	Good
Structure:	Fair
ULE (years):	20+
Arb. Value	High
Comments / Works:	Formative prune.

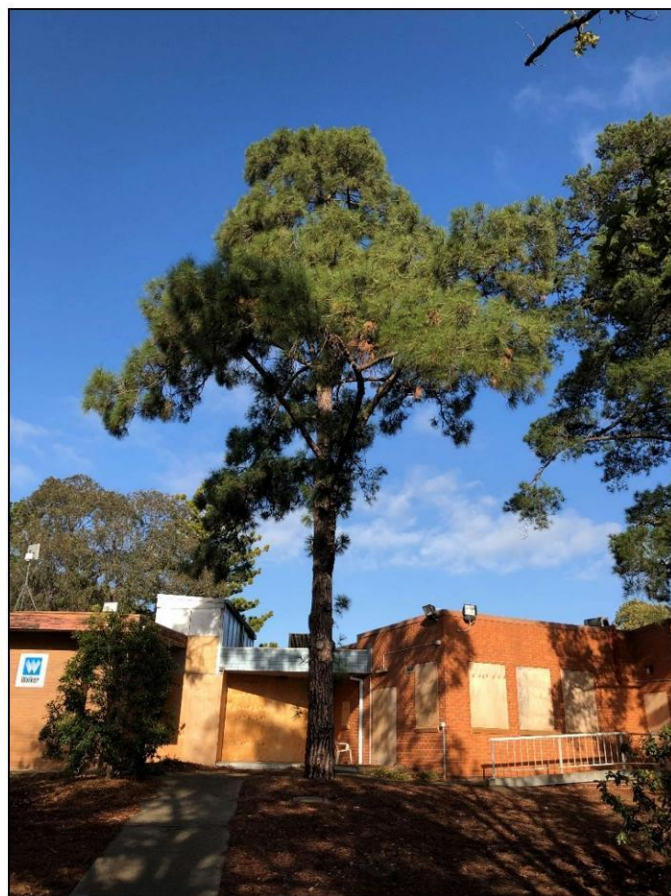
**Tree No. 23.**

Tree No.	23
Existing Tree No.:	185
Botanic Name:	Pinus canariensis
Common Name:	Canary Island Pine
Origin:	Exotic
Size (m):	18 x 14
DBH (cm):	60
TPZ (m):	7.2
Age:	Mature
Health:	Fair
Structure:	Fair
ULE (years):	10 – 20
Arb. Value	Medium
Comments / Works:	-

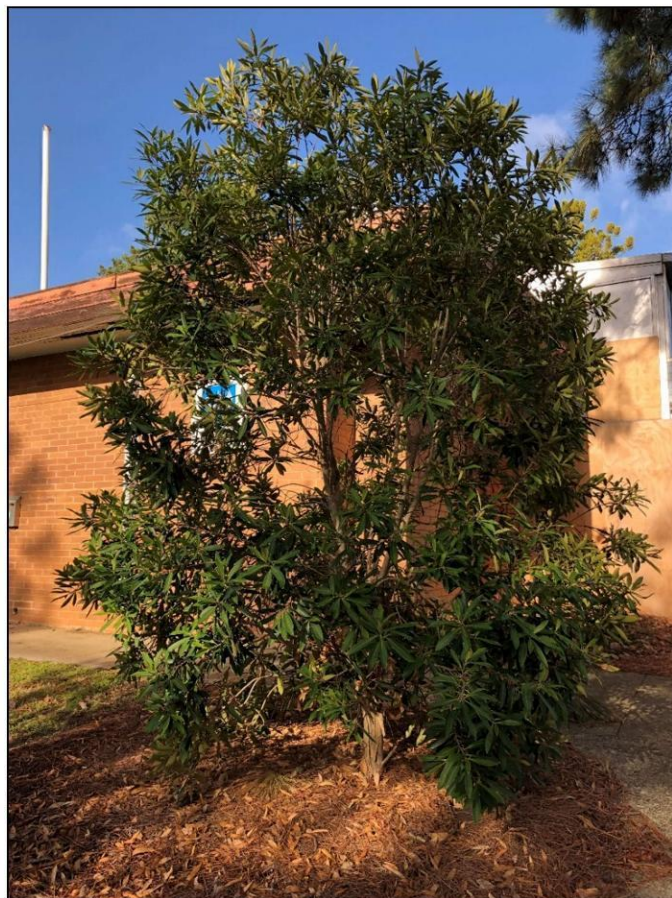
**Tree No. 24.**

Tree No.:	24
Existing Tree No.:	185b
Botanic Name:	Tristaniopsis laurina
Common Name:	Kanooka
Origin:	Vic. Native
Size (m):	3 x 2
DBH (cm):	Multi 6
TPZ (m):	2.4
Age:	Semi mature
Health:	Good
Structure:	Poor
ULE (years):	0
Arb. Value	Low
Comments / Works:	Remove no replacement.

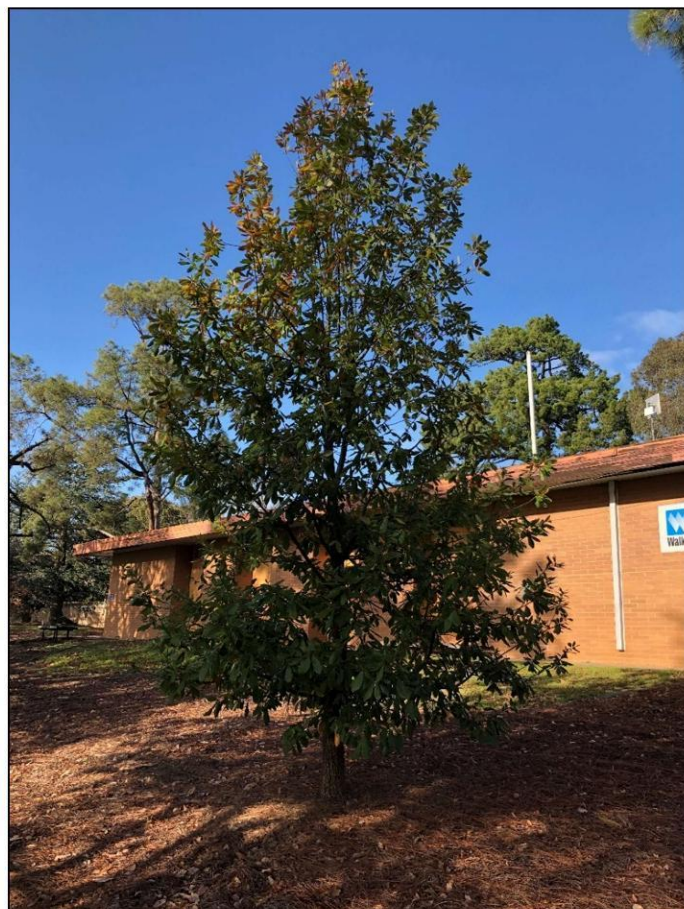
**Tree No. 25.**

Tree No.:	25
Existing Tree No.:	185c
Botanic Name:	Quercus canariensis
Common Name:	Algerian Oak
Origin:	Exotic
Size (m):	7 x 3
DBH (cm):	10
TPZ (m):	2.0
Age:	Mature
Health:	Fair
Structure:	Fair
ULE (years):	20+
Arb. Value	High
Comments / Works:	-

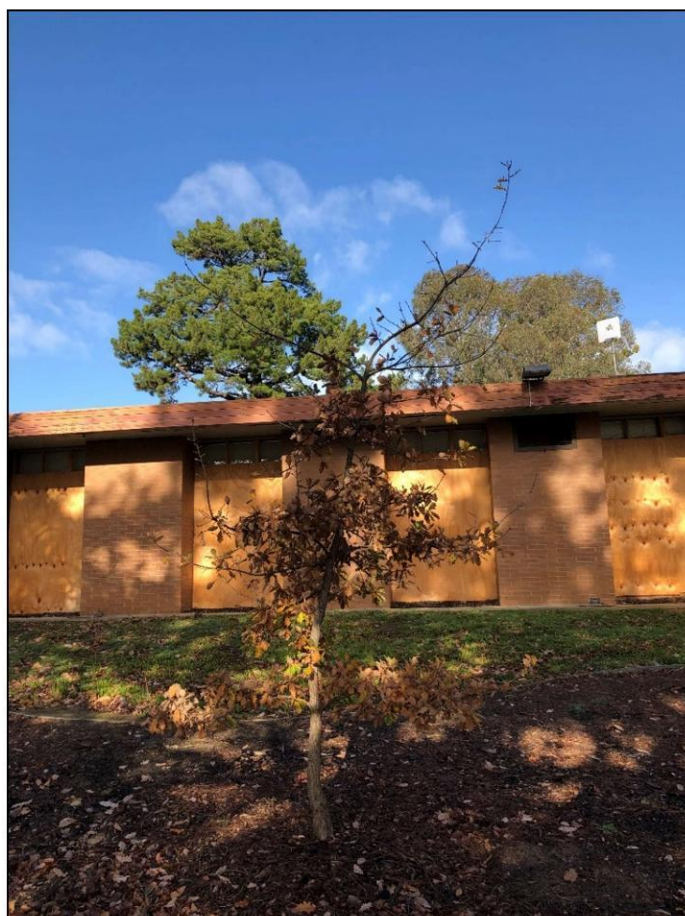
**Tree No. 26.**

Tree No.:	26
Existing Tree No.:	1143a
Botanic Name:	Quercus canariensis
Common Name:	Algerian Oak
Origin:	Exotic
Size (m):	5 x 3
DBH (cm):	5
TPZ (m):	2.0
Age:	Mature
Health:	Good
Structure:	Good
ULE (years):	20+
Arb. Value	High
Comments / Works:	-

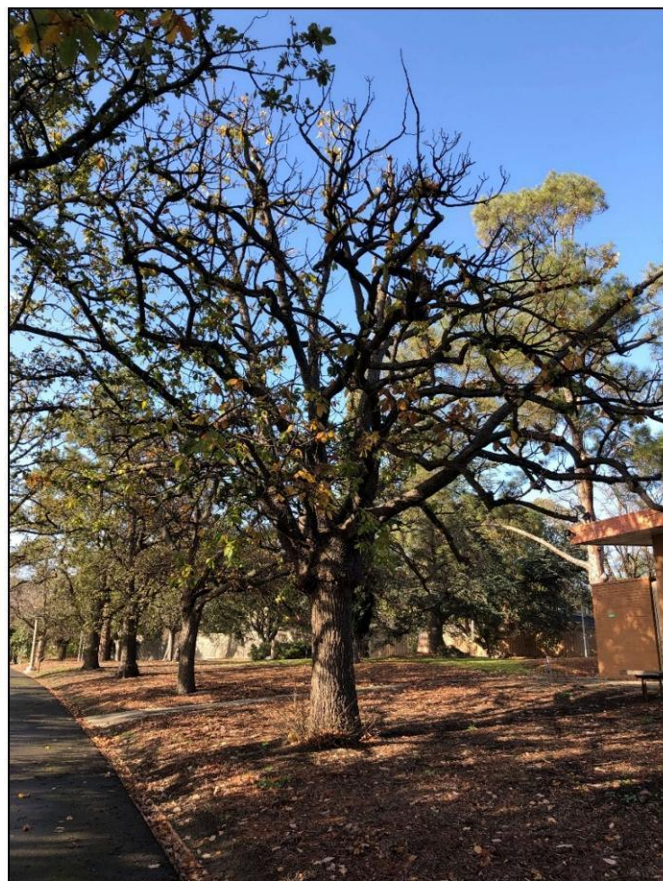
Tree No. 27.

Tree No.:	27
Existing Tree No.:	1143
Botanic Name:	Quercus canariensis
Common Name:	Algerian Oak
Origin:	Exotic
Size (m):	11 x 13
DBH (cm):	60
TPZ (m):	7.2
Age:	Mature
Health:	Fair
Structure:	Fair
ULE (years):	20+
Arb. Value	High
Comments / Works:	Declined & branch tips lopped, regenerating.

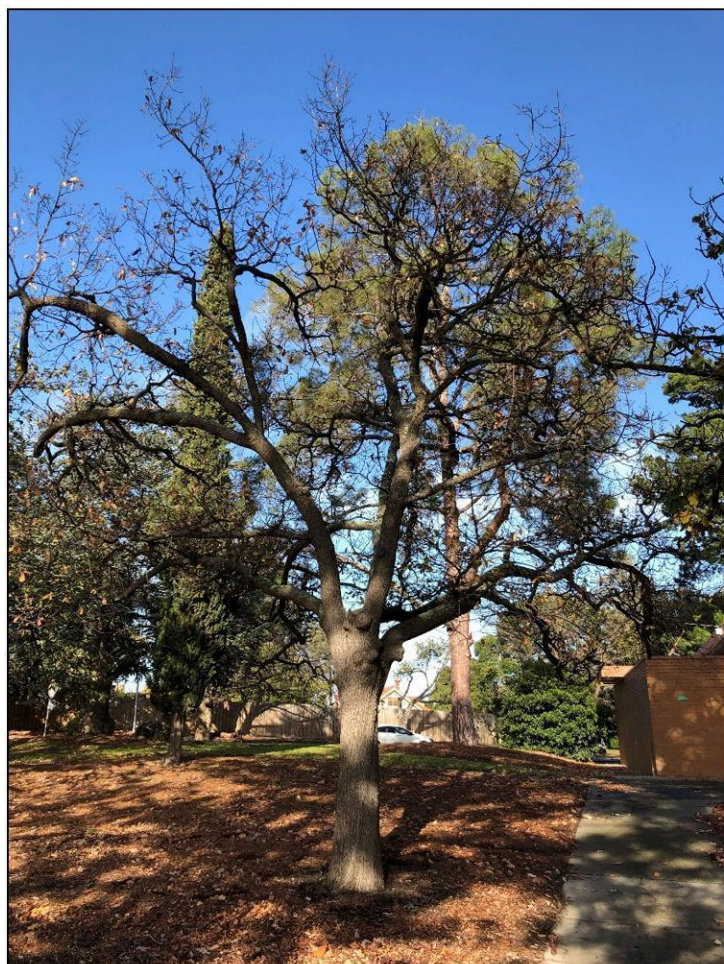
Tree No. 28.

Tree No.:	28
Existing Tree No.:	1151
Botanic Name:	Quercus robur
Common Name:	English Oak
Origin:	Exotic
Size (m):	10 x 10
DBH (cm):	40
TPZ (m):	4.8
Age:	Mature
Health:	Good
Structure:	Fair
ULE (years):	20+
Arb. Value	High
Comments / Works:	-

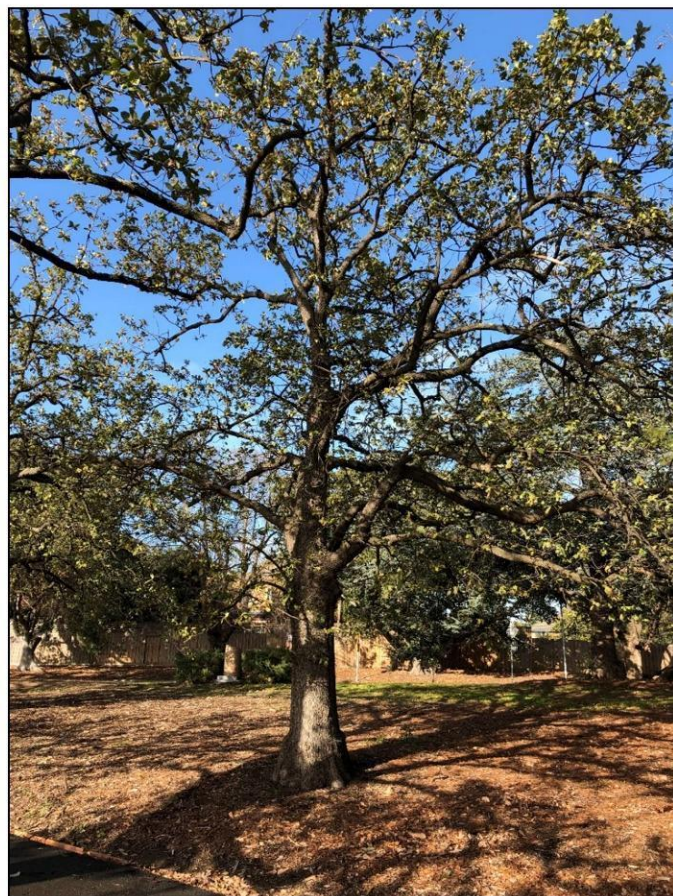
**Tree No. 29.**

Tree No.:	29
Existing Tree No.:	1150
Botanic Name:	Quercus canariensis
Common Name:	Algerian Oak
Origin:	Exotic
Size (m):	11 x 13
DBH (cm):	57
TPZ (m):	6.8
Age:	Mature
Health:	Good
Structure:	Fair
ULE (years):	20+
Arb. Value	High
Comments / Works:	Partly suppressed by tree on other side of avenue.

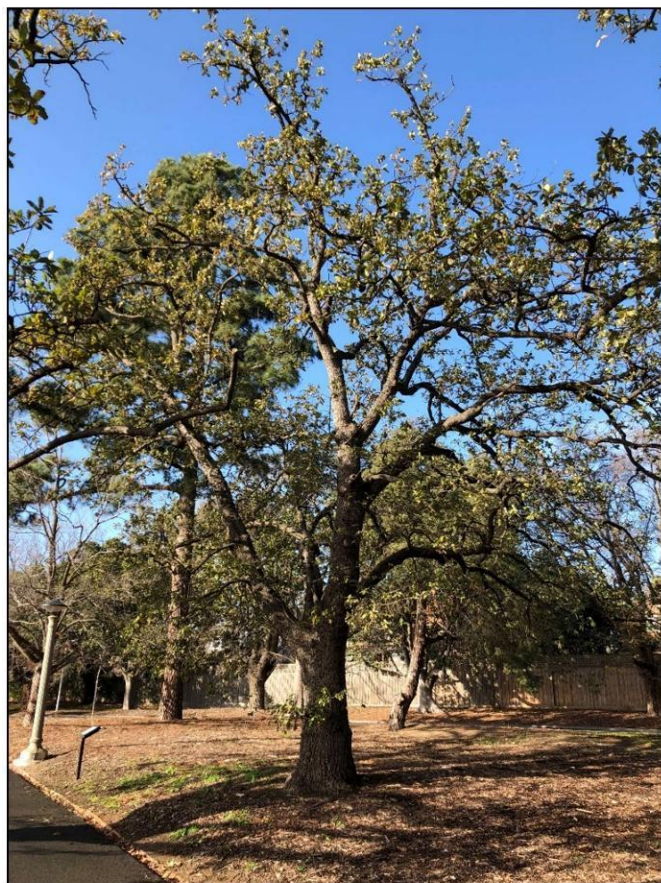
**Tree No. 30.**

Tree No.:	30
Existing Tree No.:	1149
Botanic Name:	Quercus canariensis
Common Name:	Algerian Oak
Origin:	Exotic
Size (m):	11 x 14
DBH (cm):	60
TPZ (m):	7.2
Age:	Mature
Health:	Good
Structure:	Fair
ULE (years):	20+
Arb. Value	High
Comments / Works:	-

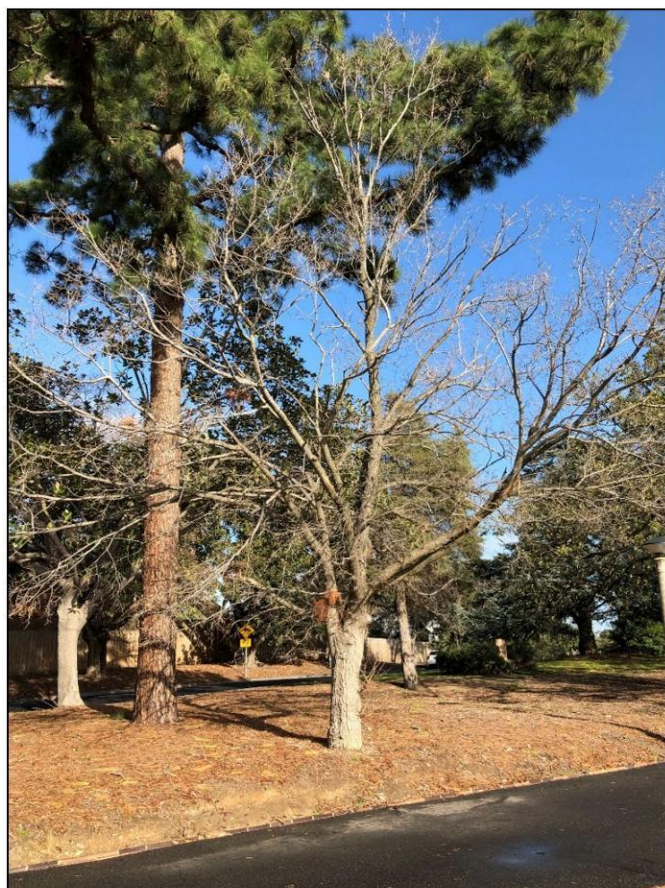
**Tree No. 31.**

Tree No.:	31
Existing Tree No.:	1160
Botanic Name:	Ulmus procera
Common Name:	English Elm
Origin:	Exotic
Size (m):	10 x 8
DBH (cm):	30/20
TPZ (m):	4.3
Age:	Mature
Health:	Fair
Structure:	Poor
ULE (years):	5 – 10
Arb. Value	Medium
Comments / Works:	Suppressed by 34.

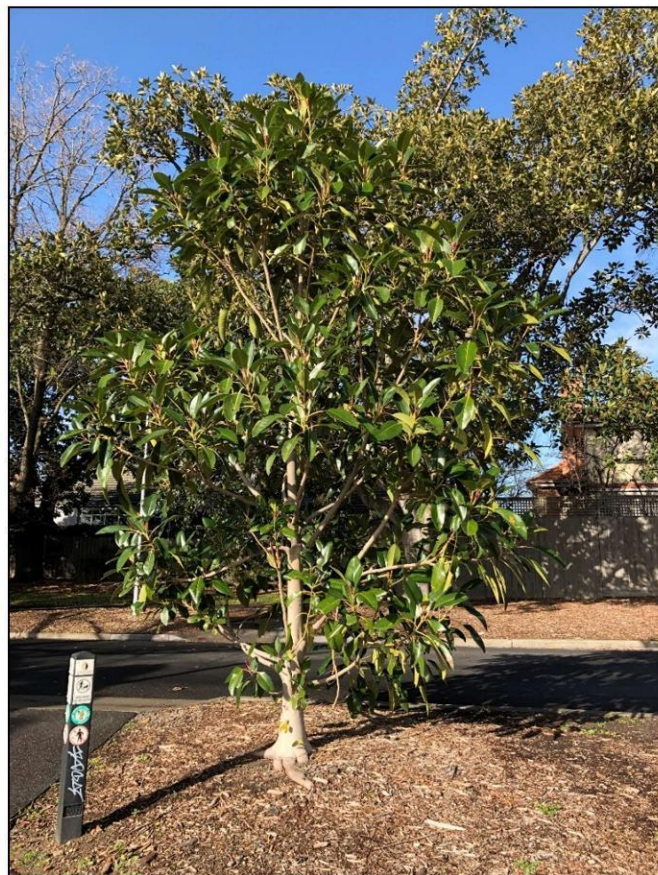
**Tree No. 32.**

Tree No.:	32
Existing Tree No.:	149a
Botanic Name:	Ficus macrophylla
Common Name:	Moreton Bay Fig
Origin:	Aust. Native
Size (m):	4 x 3
DBH (cm):	10
TPZ (m):	2.0
Age:	Semi mature
Health:	Good
Structure:	Good
ULE (years):	20+
Arb. Value	High
Comments / Works:	Planted close to path, potential infrastructure damage in future.

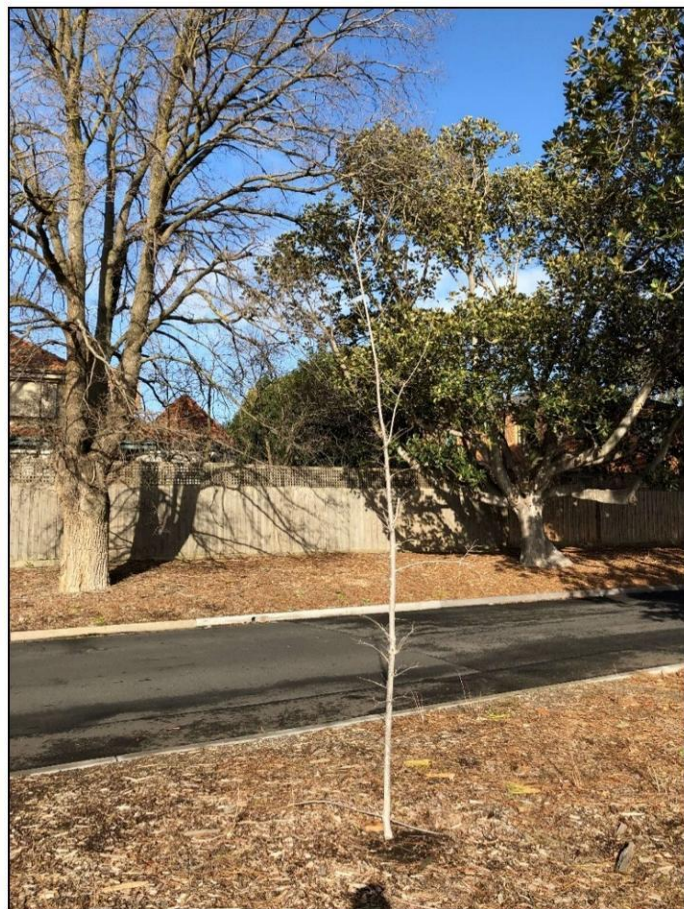
**Tree No. 33.**

Tree No.:	33
Existing Tree No.:	1169a
Botanic Name:	Ulmus procera
Common Name:	English Elm
Origin:	Exotic
Size (m):	1 x 0.5
DBH (cm):	2
TPZ (m):	2.0
Age:	Juvenile
Health:	Poor
Structure:	Poor
ULE (years):	0
Arb. Value	Low
Comments / Works:	New planting. Remove and replace with same species.
