TREE MANAGEMENT PLAN

1 - 8 Main Drive, Kew.

8 OCTOBER 2019

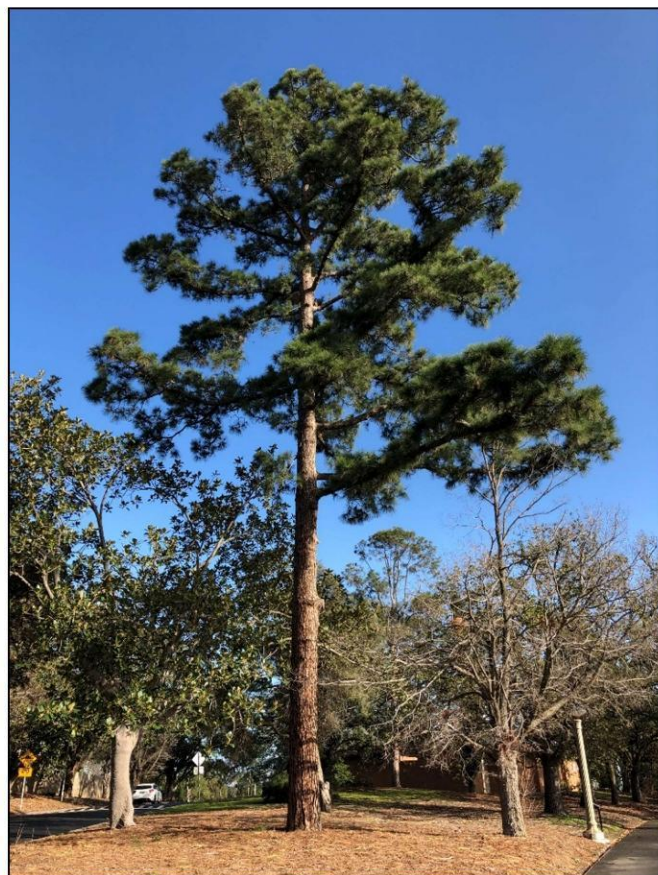
**Tree No. 34.**

Tree No.	34
Existing Tree No.:	149
Botanic Name:	Pinus canariensis
Common Name:	Canary Island Pine
Origin:	Exotic
Size (m):	23 x 12
DBH (cm):	68
TPZ (m):	8.0
Age:	Mature
Health:	Fair
Structure:	Fair
ULE (years):	10 – 20
Arb. Value	Medium
Comments / Works:	-

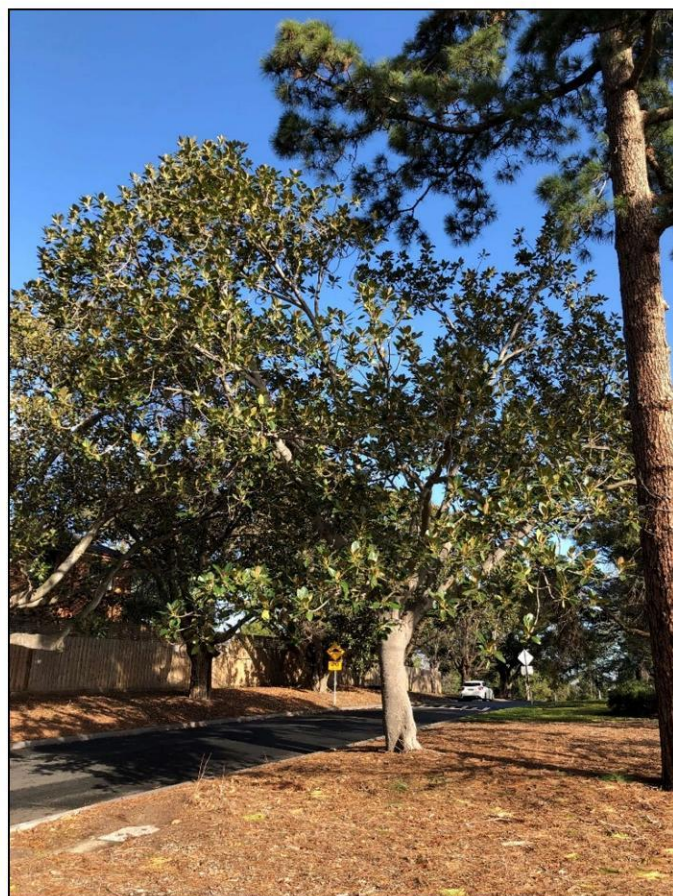
**Tree No. 35.**

Tree No.:	35
Existing Tree No.:	1159
Botanic Name:	Ficus macrophylla
Common Name:	Moreton Bay Fig
Origin:	Aust. Native
Size (m):	11 x 15
DBH (cm):	44
TPZ (m):	5.3
Age:	Mature
Health:	Fair
Structure:	Poor
ULE (years):	10 – 20
Arb. Value	Medium
Comments / Works:	No central leader.

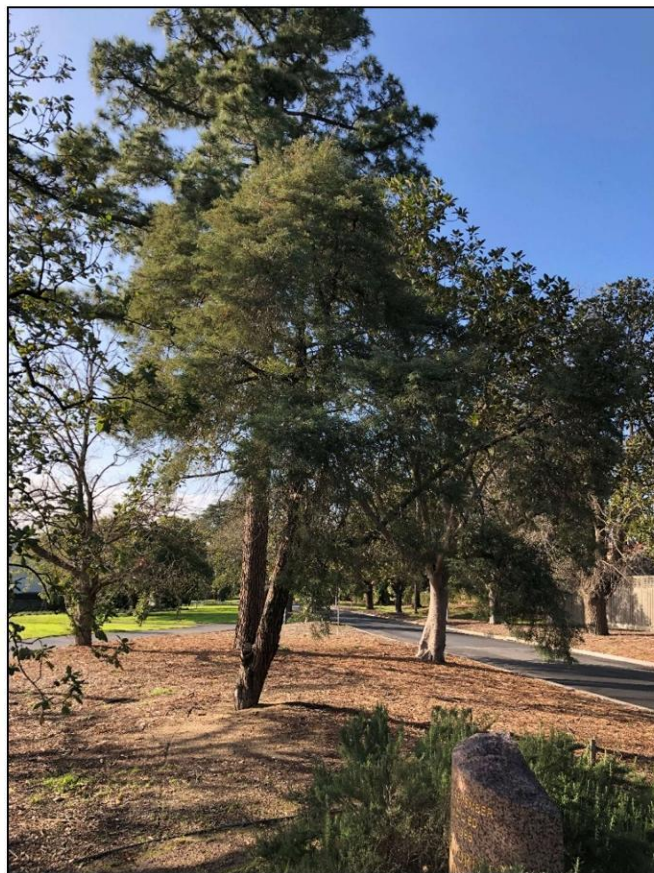
**Tree No. 36.**

Tree No.	36
Existing Tree No.:	1149a
Botanic Name:	Cupressus funiberis
Common Name:	Chinese Weeping Cypress
Origin:	Exotic
Size (m):	8 x 7
DBH (cm):	30
TPZ (m):	3.6
Age:	Over Mature
Health:	Poor
Structure:	Poor
ULE (years):	0 – 5
Arb. Value	Low
Comments / Works:	Remove and replace with different species.

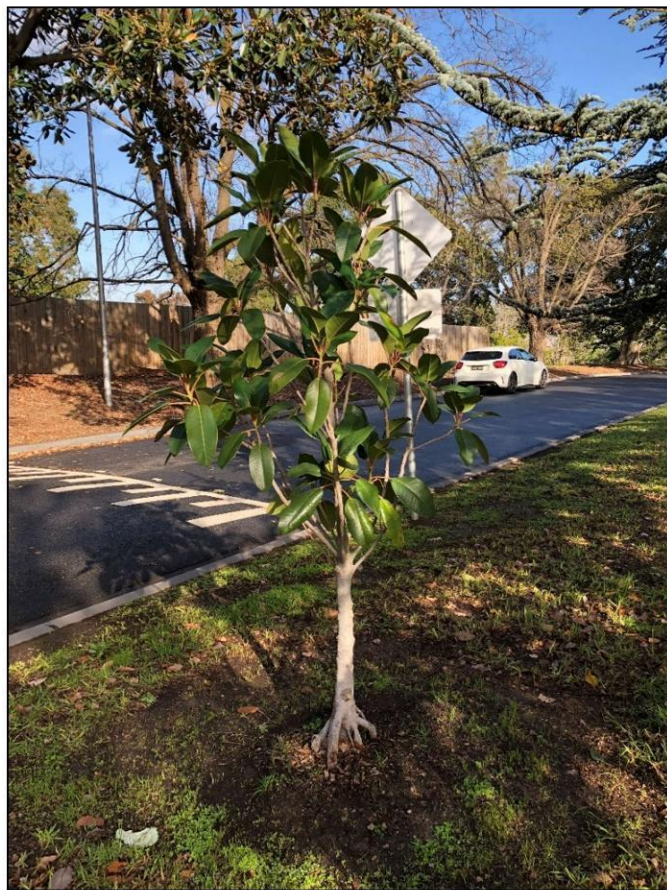
**Tree No. 37.**

Tree No.:	37
Existing Tree No.:	1153a
Botanic Name:	Ficus macrophylla
Common Name:	Moreton Bay Fig
Origin:	Aust. Native
Size (m):	2 x 1
DBH (cm):	3
TPZ (m):	2.0
Age:	Juvenile
Health:	Good
Structure:	Fair
ULE (years):	0 – 5
Arb. Value	Low
Comments / Works:	Planted too high, replant or replace with same species.

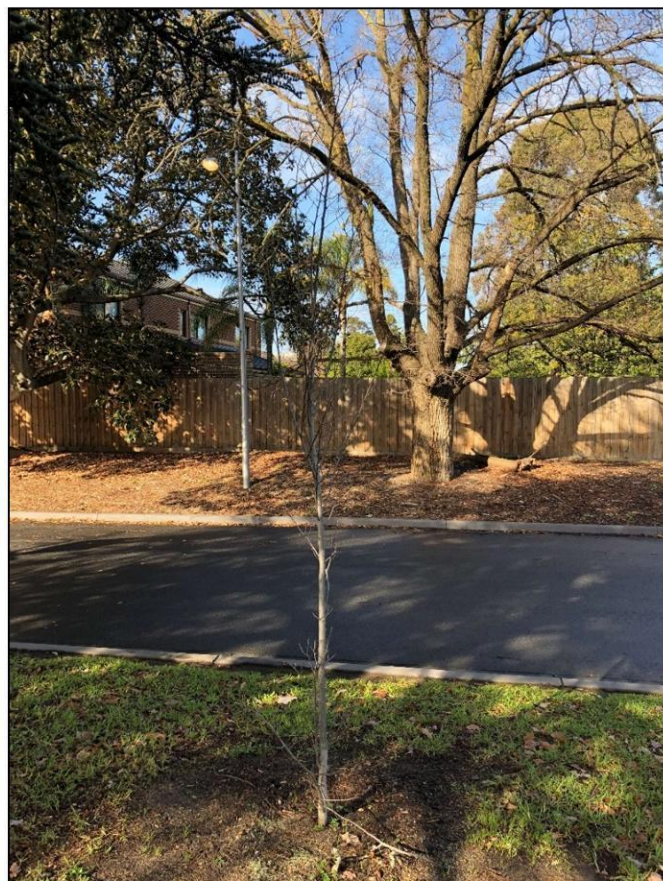
**Tree No. 38.**

Tree No.:	38
Existing Tree No.:	1153b
Botanic Name:	Ulmus procera
Common Name:	English Elm
Origin:	Exotic
Size (m):	3 x 0.5
DBH (cm):	2
TPZ (m):	2.0
Age:	Juvenile
Health:	Fair
Structure:	Fair
ULE (years):	20+
Arb. Value	High
Comments / Works:	Formative prune.

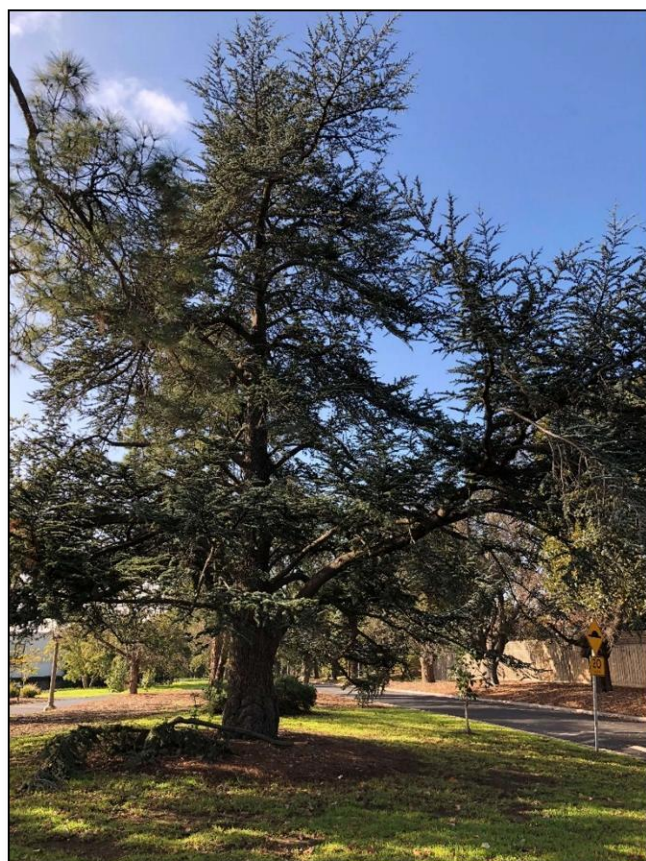
**Tree No. 39.**

Tree No.:	39
Existing Tree No.:	1153
Botanic Name:	Cedrus atlantica 'Glauca'
Common Name:	Blue Atlas Cedar
Origin:	Exotic
Size (m):	11 x 15
DBH (cm):	67
TPZ (m):	8.0
Age:	Juvenile
Health:	Good
Structure:	Fair
ULE (years):	20+
Arb. Value	High
Comments / Works:	Prune out minor deadwood.

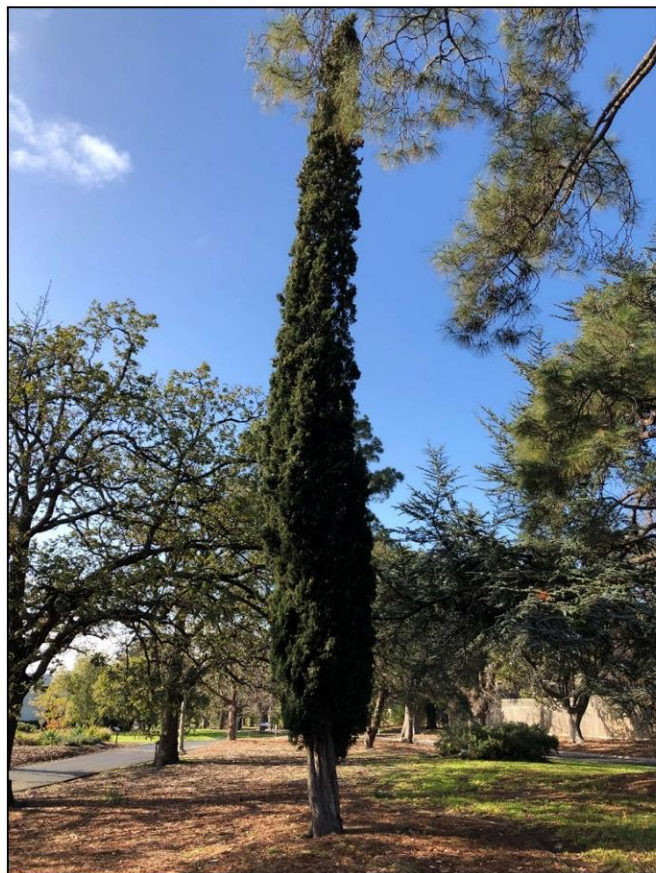
**Tree No. 40.**

Tree No.:	40
Existing Tree No.:	1152
Botanic Name:	Cupressus sempervirens
Common Name:	Pencil Pine
Origin:	Exotic
Size (m):	11 x 2
DBH (cm):	28
TPZ (m):	3.4
Age:	Mature
Health:	Good
Structure:	Good
ULE (years):	20+
Arb. Value	High
Comments / Works:	-
