**PRELIMINARY SITE INSPECTION
AND SUMMARY REPORT.**

CITY OF BOROONDARA

KEW COTTAGES

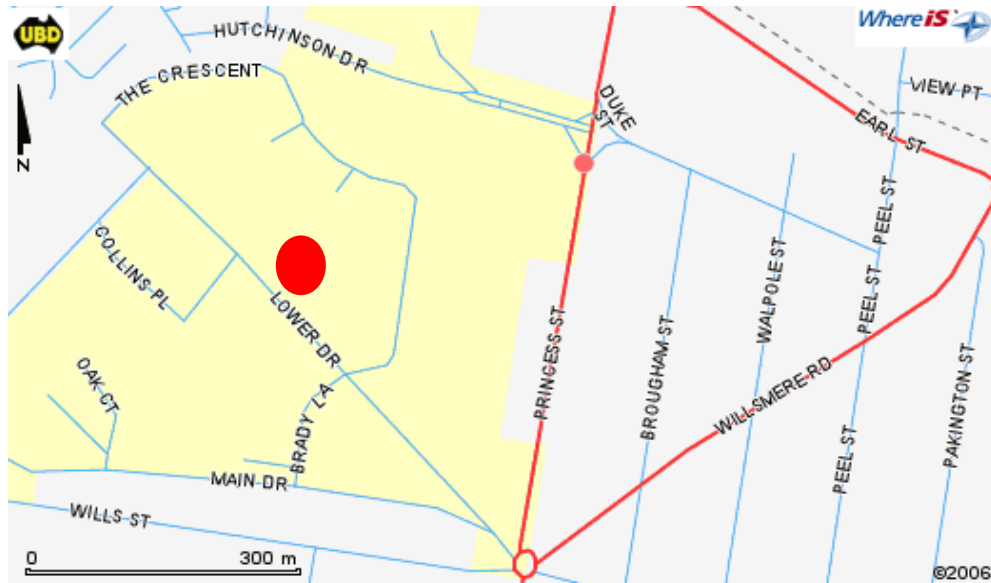
Plate 1

The red circle in plate 1 (page 4) identifies the approximate location of the Bishop Pine (*Pinus muricata*) discussed in this report. The tree is located in a lawn area, to the north of Lower Drive and to the west of Brady Lane.

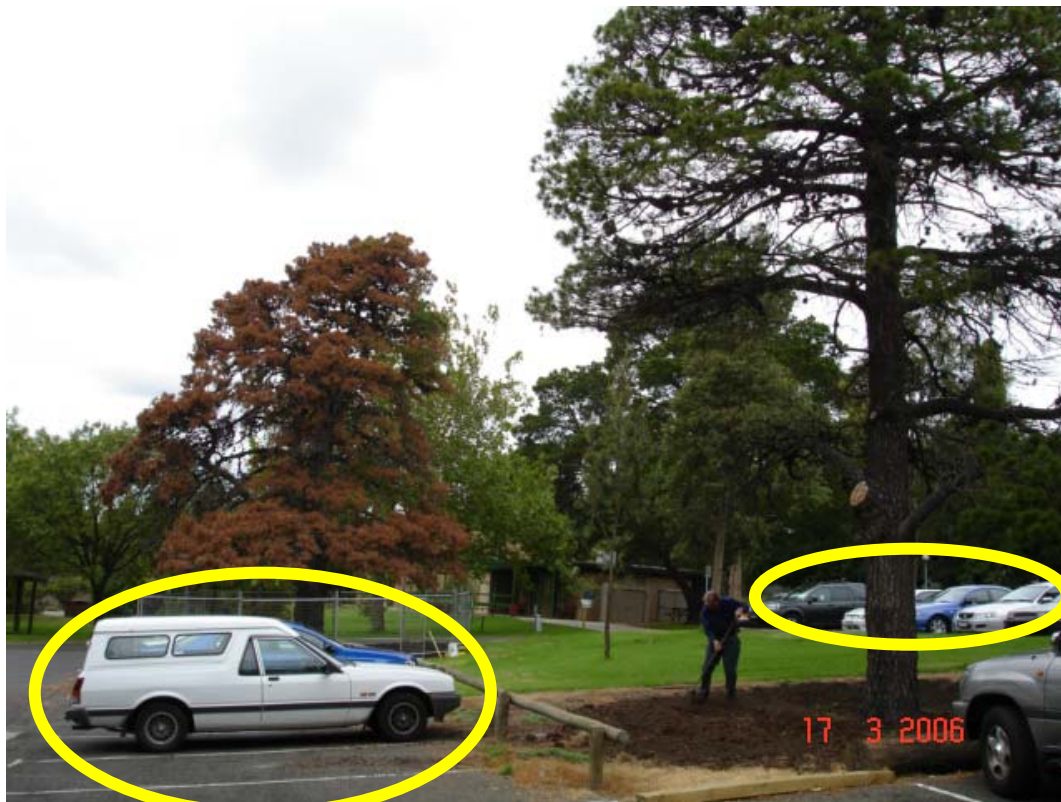
Plate 2

There is evidence of recent works within the Auxiliary Root Zone (ARZ); this root zone is deemed to be 1.5 times the height of the tree. It can be seen in plate 2 & 6 (page 4 & 6) that additional car parking spaces have been recently constructed in the ARZ of this tree. And although the exact construction method undertaken is not known: compaction to the immediate area or the application of lime to assist with the road base foundation would have resulted in some damage to the feeder roots in the ARZ area.

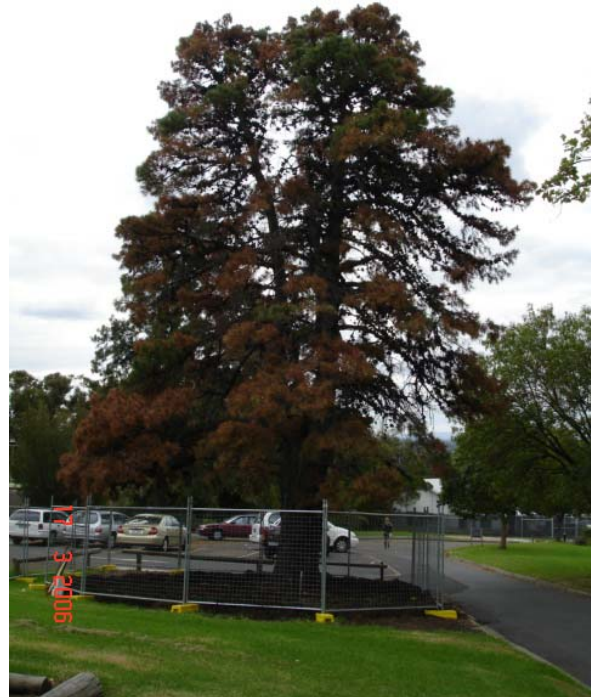
A chain mesh fence has been erected to define the area of ground treated with metalaxyl (Plate 4).

Plate 4 (page 6) indicates the amount of dead foliage in the lower and upper canopy, from the ground visual inspection it is estimated that only 5% of the total canopy foliage is alive.

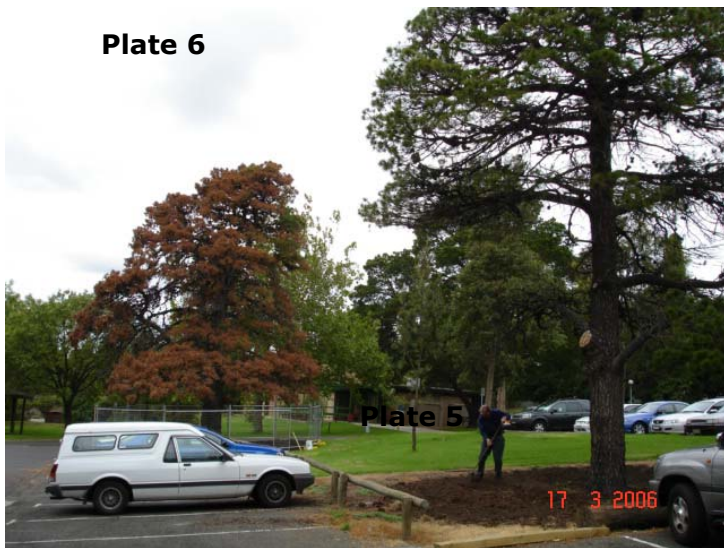
Plate 6

It was then noted that the worker took the tools and crossed the lawn area and commenced work in another area of the property without cleaning and sanitising tools or footwear. This simple lack of basic fungal spread mitigation allows the sites to be potentially cross contaminated (Plate 6 page 6).

Basic control of any contaminated site whether fungi or other requires that any person or object taken from an infected point to any other point, be sanitised.

Site manager's and or responsible person's must take measures to provide adequate employee and or contractor training and resources to ensure the contamination of additional sites / areas does not occur.

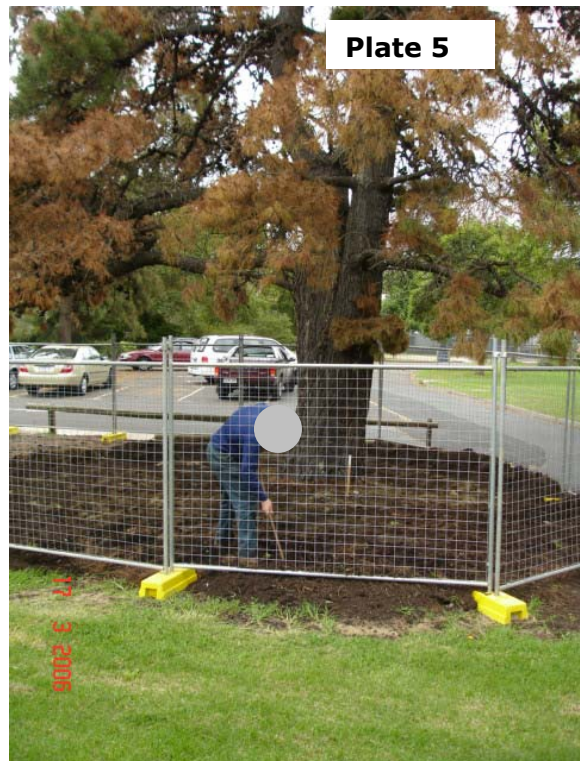
Plate 5

During my site investigation it was noted that workers were entering the fenced off area and carrying out remedial works (plate 5).

The remedial works consisted of the worker removing the top layer of soil using hand tools, applying the fungicide and the relaying the top soil over the treated areas (Plate 5).

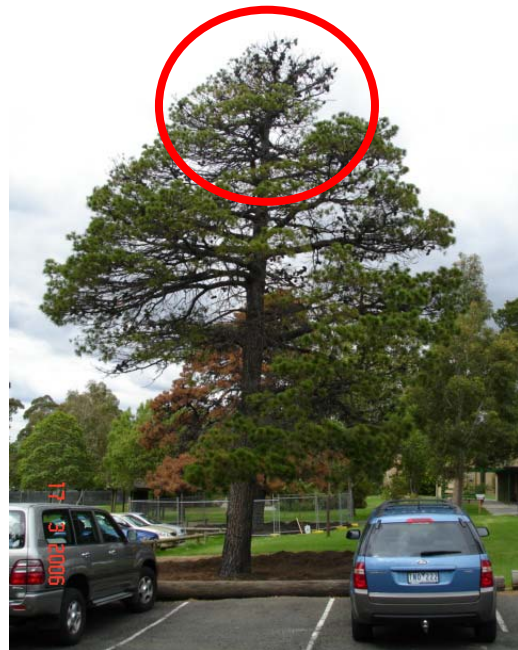
Plate 7 is a photo of a Bishop pine located to the west of the Bishop pine discussed in this report. The general density of the canopy is thin. Thin canopies are characteristics of a tree entering into decline. The red circle (Plate 7) indicates where the canopy thinning is most prevalent.
