Site Inspection notes. SFES Diagnostic number: 06-12

Location: Kew Cottages. Inspection of dying Bishop Pine (*Pinus muricata*) by Ian Smith on 15/2/2006 at request of John Ball. Initial inspections carried out by Rob Galbraith.

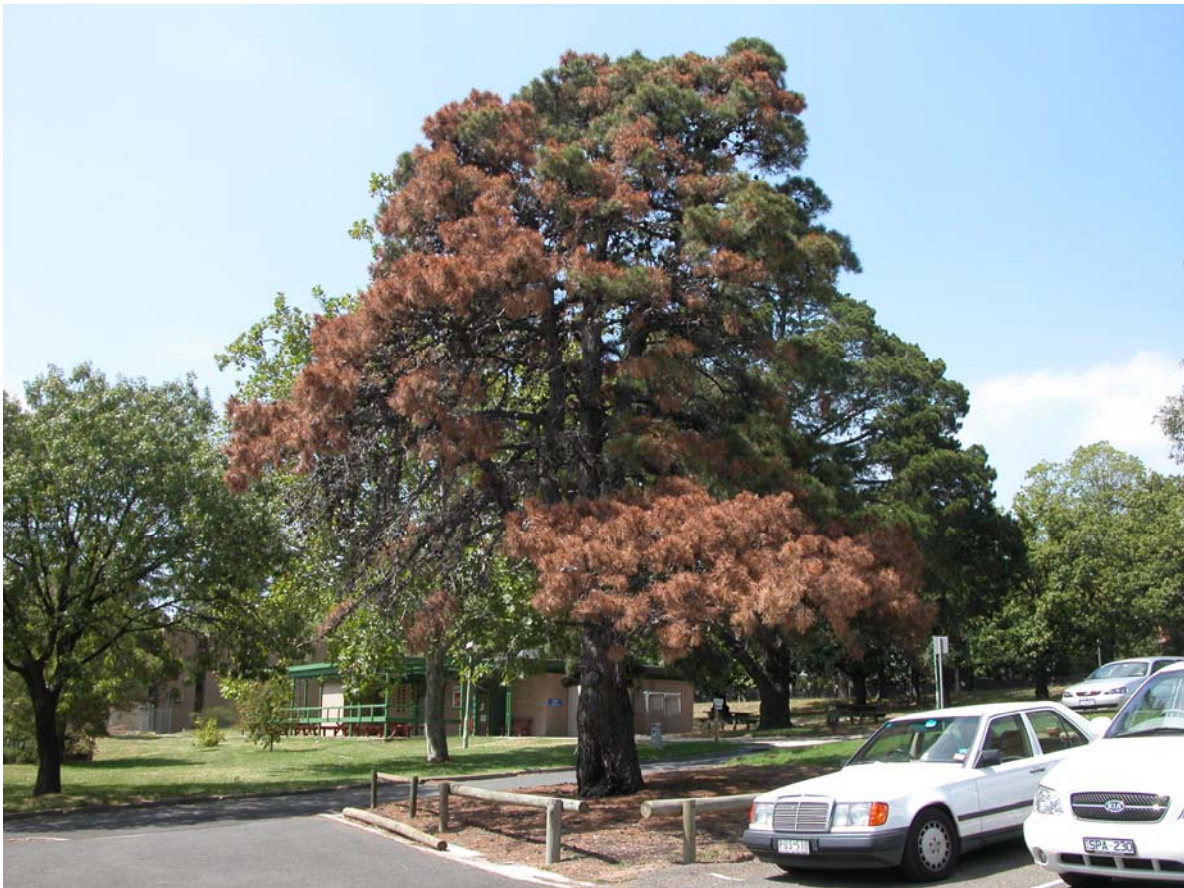
Symptoms: Tree dying off primarily on one side, although symptoms spreading across canopy. Symptoms suggest root problem. Some bleeding from trunk. Little evidence of any insect damage to trunk or branches.

Resin bleeding at base

Resin on trunk

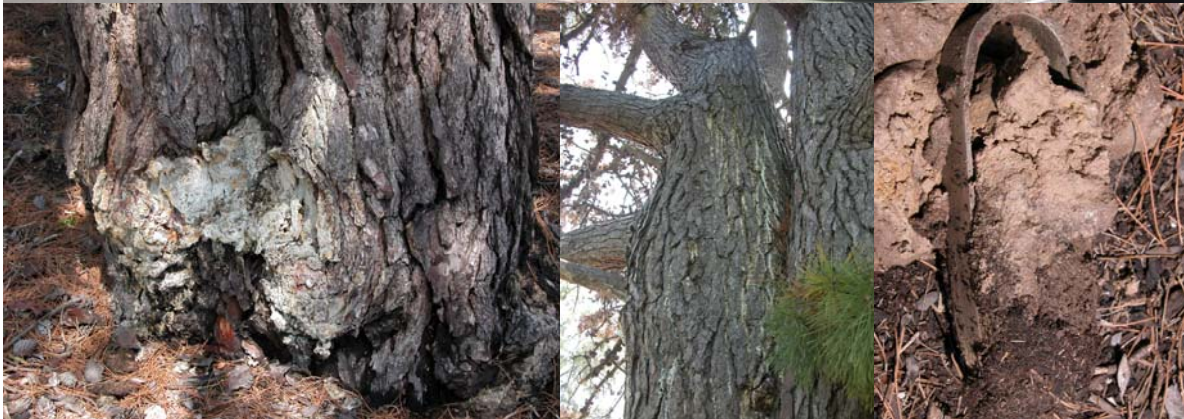
Site description: Surface soils dry to the north and moist to the south, however both soil cores were very wet at 100cm depth. Either overwatered or leaking pipes. Mulch applied around tree.

Wet soil @ 90-100 cm
