Tree Identification & Retention

SIGNIFICANT TREE SURVEY**SITE:** Kew Residential Services, Princess Street, Kew**DATE:** 15-07-03

PROJECT
Kew Residential Services
Princess Street, Kew

DRAWING
Significant Tree Locations

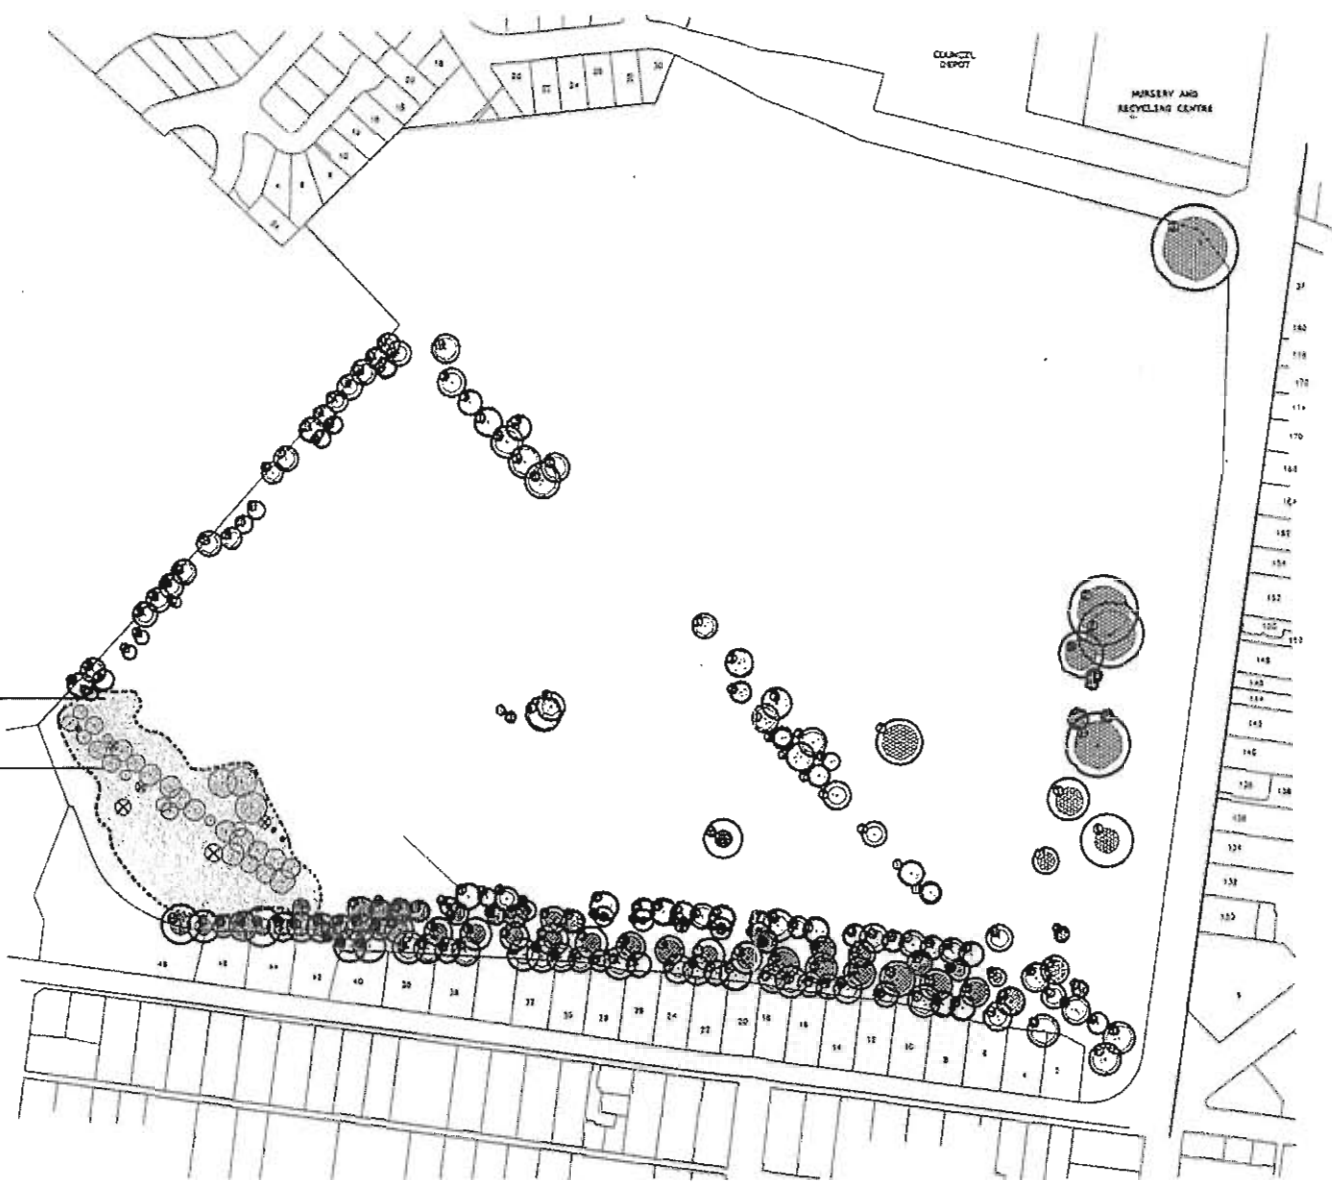
For all trees identified for retention Tree Protection Zones have been prepared following the guidelines prepared by Matheny & Clark in *Trees & Development*. The significant trees are all located on Plan 03-090 together with their proposed Tree Protection Zones. The identification of all significant trees together with an assessment of their health, tree protection zone and required works are provided in Appendix 1.

Area of indigenous
Woolly grass (*Acrostichum* sp.)
with south-west plantation

"South-West Plantation" containing
a number of mature, largely coniferous trees
