TREE MANAGEMENT PLAN

1 - 8 Main Drive, Kew.

8 OCTOBER 2019

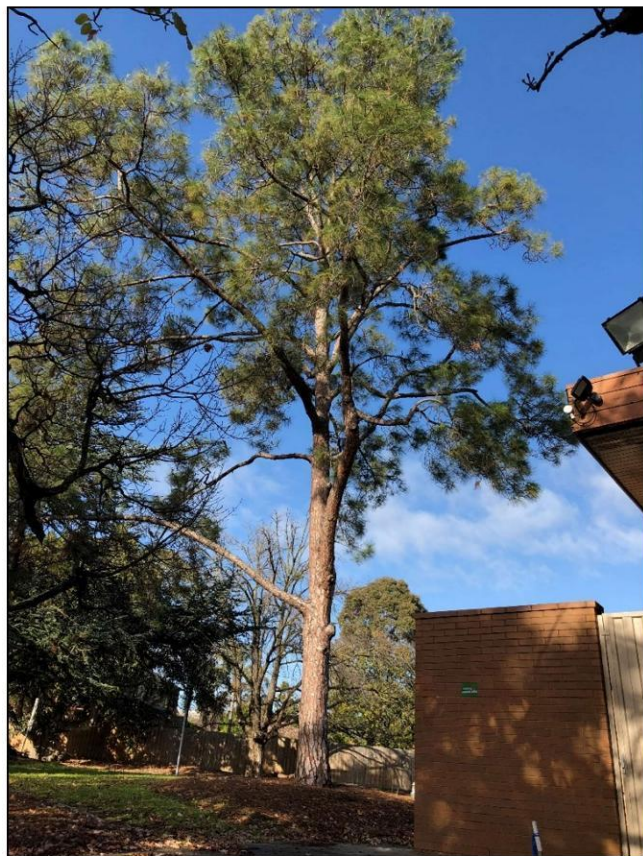
**Tree No. 41.**

Tree No.:	41
Existing Tree No.:	153
Botanic Name:	Pinus canariensis
Common Name:	Canary Island Pine
Origin:	Exotic
Size (m):	18 x 17
DBH (cm):	58
TPZ (m):	7.0
Age:	Mature
Health:	Fair
Structure:	Fair
ULE (years):	10 – 20
Arb. Value	Medium
Comments / Works:	Prune back from Tree 39

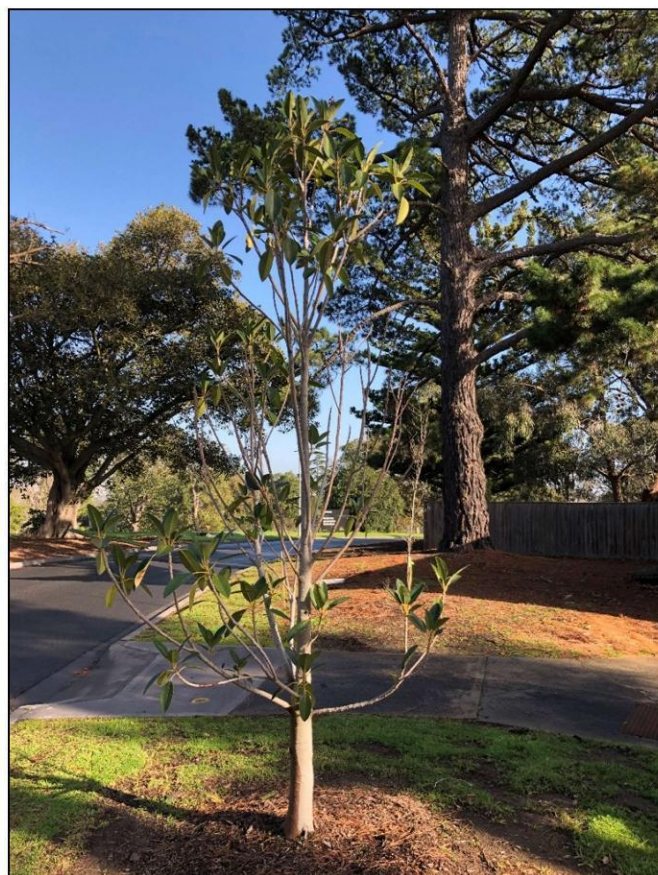
**Tree No. 42.**

Tree No.:	42
Existing Tree No.:	153a
Botanic Name:	Ficus macrophylla
Common Name:	Moreton Bay Fig
Origin:	Aust. Native
Size (m):	3 x 1
DBH (cm):	7
TPZ (m):	2.0
Age:	Juvenile
Health:	Fair
Structure:	Fair
ULE (years):	20+
Arb. Value	High
Comments / Works:	-

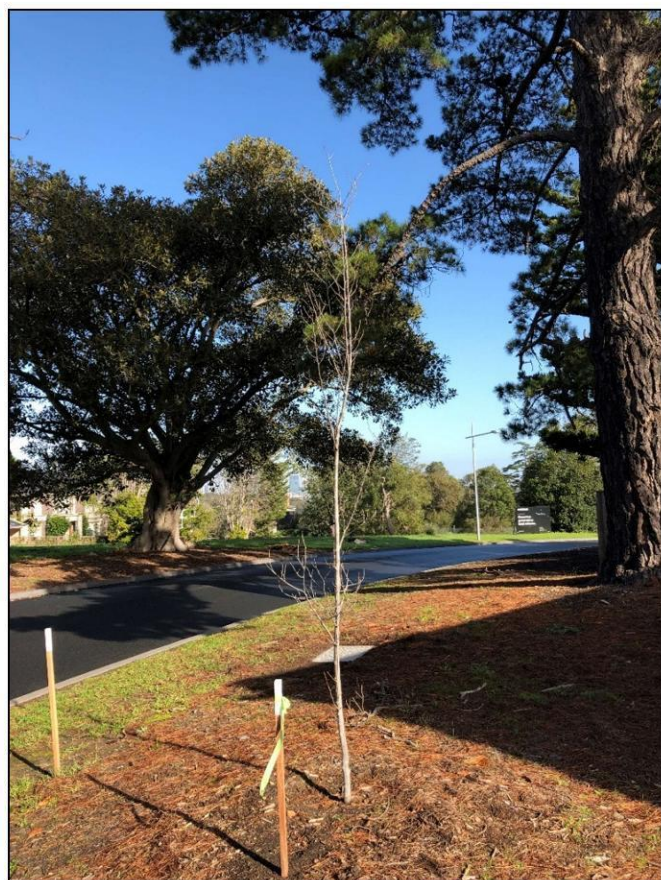
**Tree No. 43.**

Tree No.:	43
Existing Tree No.:	156a
Botanic Name:	Ulmus procera
Common Name:	English Elm
Origin:	Exotic
Size (m):	3 x 0.5
DBH (cm):	2
TPZ (m):	2.0
Age:	Juvenile
Health:	Fair
Structure:	Fair
ULE (years):	20+
Arb. Value	High
Comments / Works:	-

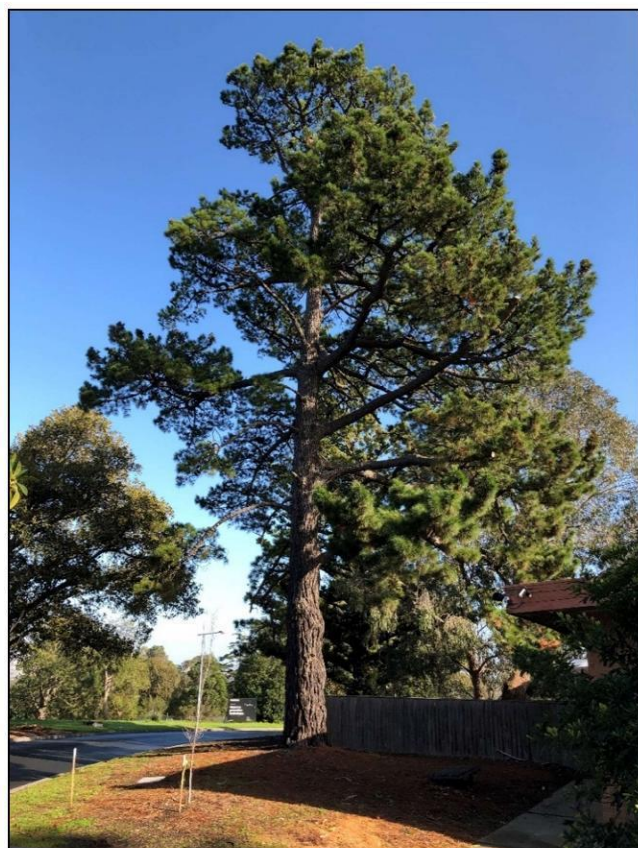
**Tree No. 44.**

Tree No.:	44
Existing Tree No.:	156
Botanic Name:	Pinus radiata
Common Name:	Monterey Pine
Origin:	Exotic
Size (m):	19 x 15
DBH (cm):	96
TPZ (m):	11.5
Age:	Mature
Health:	Good
Structure:	Fair
ULE (years):	5 – 10
Arb. Value	Medium
Comments / Works:	-

- 6.19 It is recommended that the project arborist review Trees 44 and 45 after the construction sheds have been in place for 18 months, and confirm that the sheds can remain in there, or if they should be relocated to an alternate position.

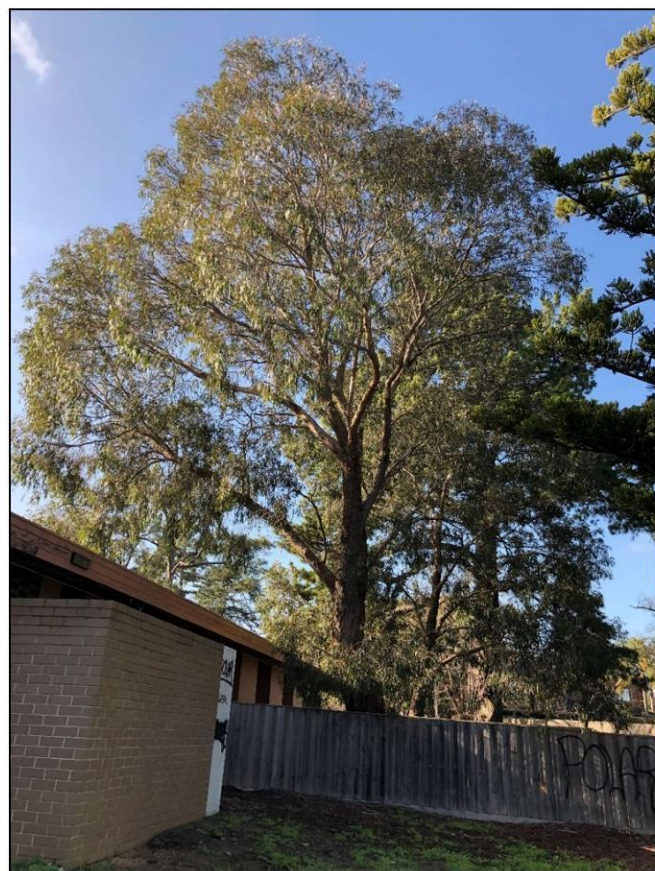
**Tree No. 45.**

Tree No.:	45
Existing Tree No.:	157
Botanic Name:	Eucalyptus Radiata
Common Name:	Narrow Leaved Peppermint Gum
Origin:	Vic. Native
Size (m):	14 x 12
DBH (cm):	75
TPZ (m):	9.0
Age:	Mature
Health:	Good
Structure:	Fair
ULE (years):	10 – 20
Arb. Value	Medium
Comments / Works:	-

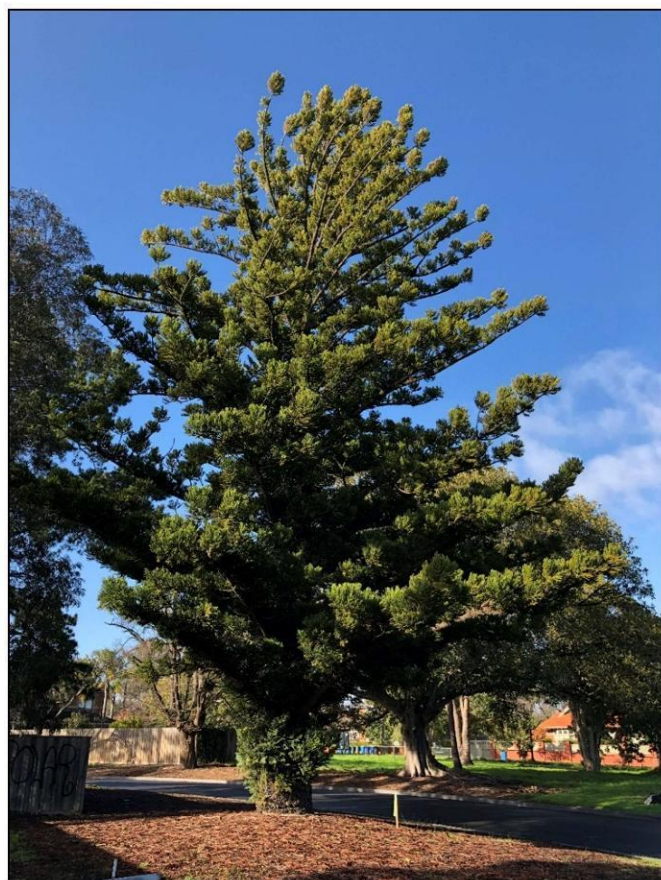
**Tree No. 46.**

Tree No.:	46
Existing Tree No.:	158
Botanic Name:	Araucaria cunninghamii
Common Name:	Hoop Pine
Origin:	Aust. Native
Size (m):	18 x 12
DBH (cm):	90
TPZ (m):	10.8
Age:	Mature
Health:	Good
Structure:	Good
ULE (years):	20+
Arb. Value	High
Comments / Works:	-

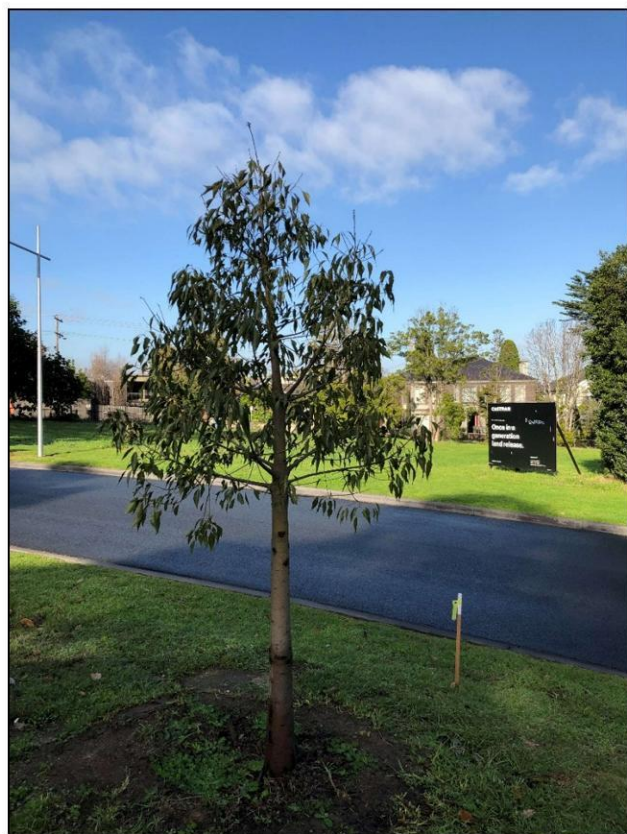
**Tree No. 47.**

Tree No.:	47
Existing Tree No.:	160
Botanic Name:	Brachychiton poulaneus
Common Name:	Kurrajong
Origin:	Vic. Native
Size (m):	3 x 1
DBH (cm):	7
TPZ (m):	2.0
Age:	Juvenile
Health:	Good
Structure:	Good
ULE (years):	20+
Arb. Value	Low
Comments / Works:	Not appropriate species. Remove, could be replanted elsewhere.
