**PRELIMINARY SITE INSPECTION
AND SUMMARY REPORT.**

CITY OF BOROONDARA

KEW COTTAGES

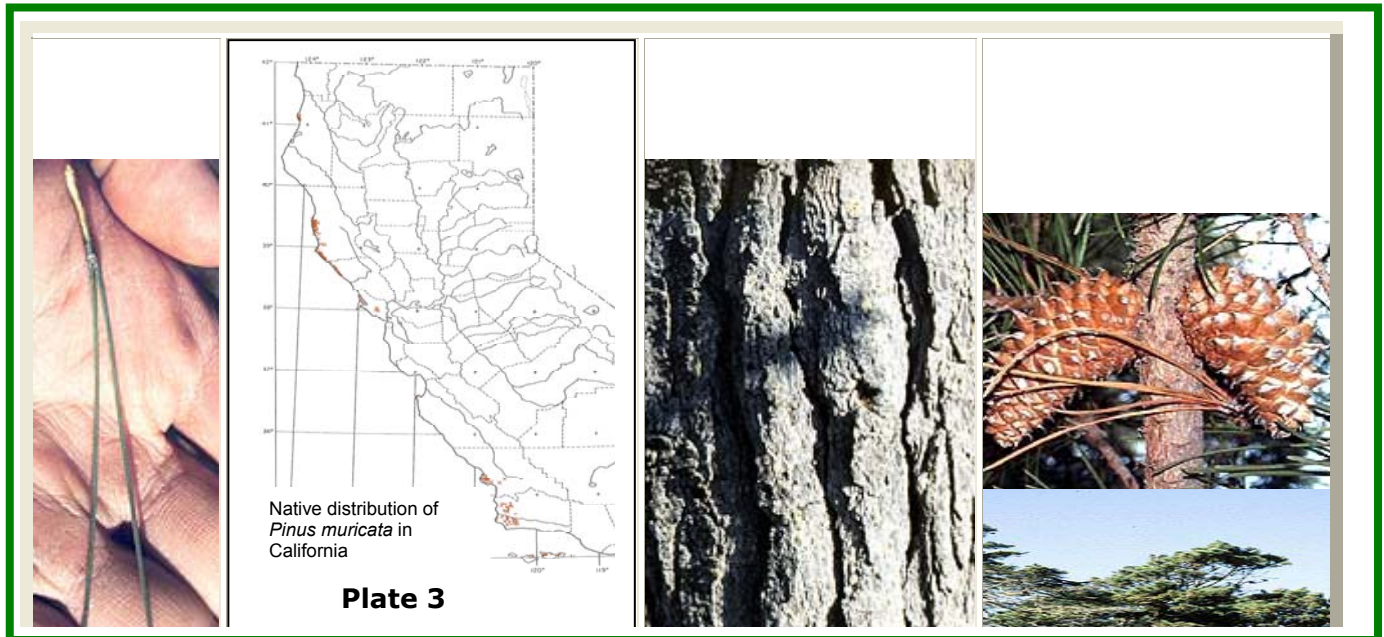
Botanical Name	<i>Pinus muricata</i>
Common Name	Bishop Pine
Tree Height metres (approximately)	10 metres
Tree Spread metres (approximately)	East & West 8 metres North & South 8 metres
Tree Age (estimated)	80 plus years
Diameter at Breast Height	Not measured due to an exclusion zone around the tree (infected area)

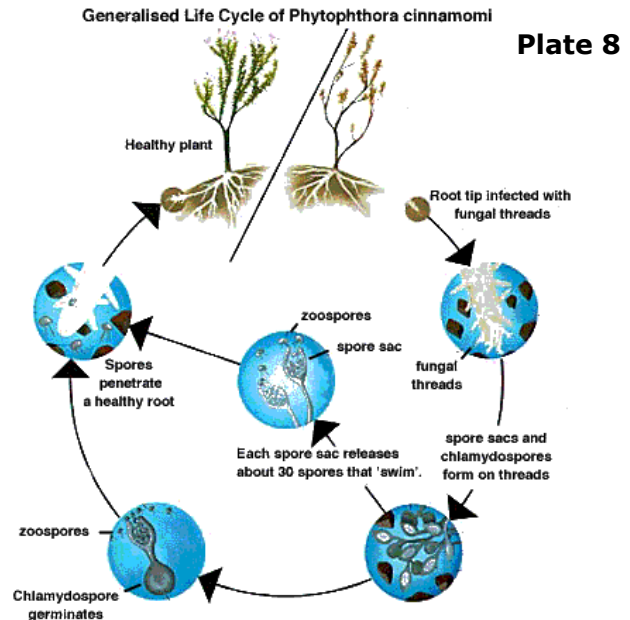
Phytophthora cinnamomi is found in many areas of Victoria as the map below shows. Areas of Melbourne are also known to be infected.
